HURRICANE FRAN EFFECTS ON COMMUNITIES
WITH AND WITHOUT SHORE PROTECTION:
A CASE STUDY AT SIX NORTH CAROLINA BEACHES

IWR Report 00-R-6

December 2000

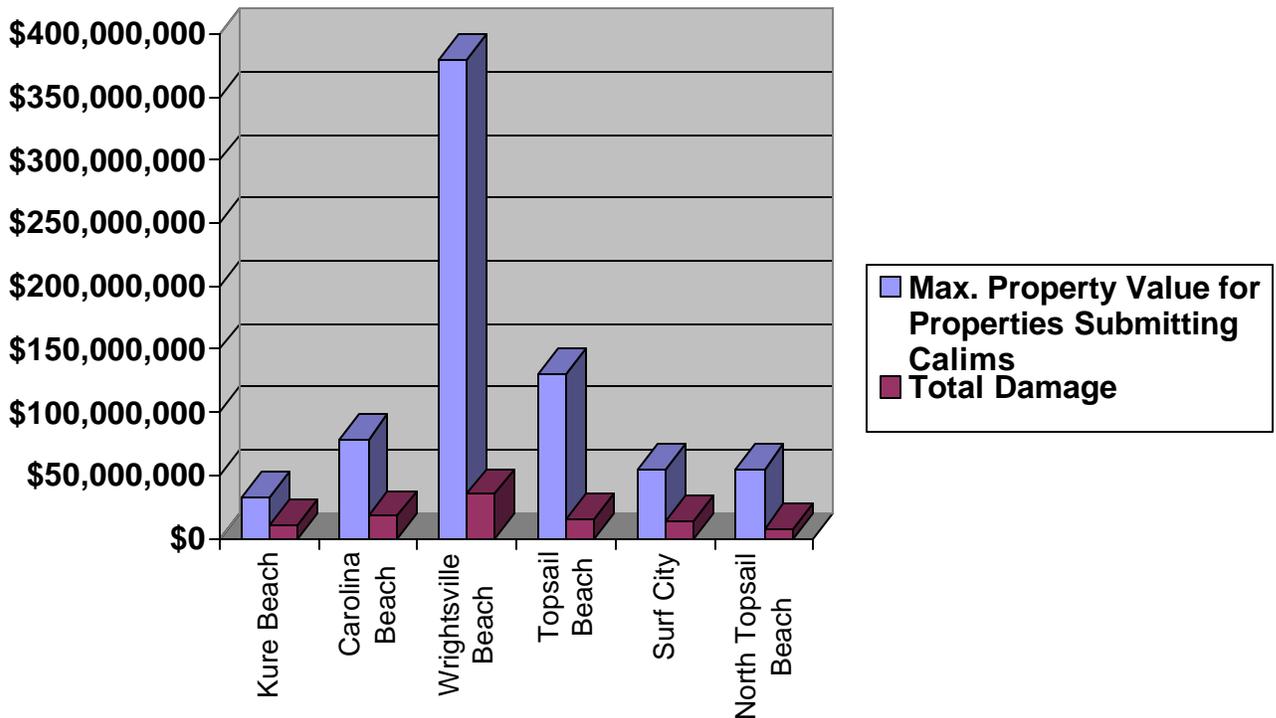
Property Values Versus Damages - Hurricane Fran

e. Damages by Community. Because of the difference in demographics (median house value, number of housing units, land area, etc.) of the various beach communities, it is more appropriate to compare percent damages, which normalizes the damages, as opposed to absolute damage numbers. The property values versus damages claimed are shown in the following figure.

Topsail Island and Kure Beach, both unprotected areas, sustained a greater percentage of damage than did Wrightsville Beach and Carolina Beach where there were shoreline projects. The shoreline protection project at Wrightsville Beach is 14,000-feet in length. The "Wrightsville Beach" community includes not only the area behind the Corps project, but also the northern end of Wrightsville Beach (Shell Island), Harbor Island and mainland Wrightsville Beach.

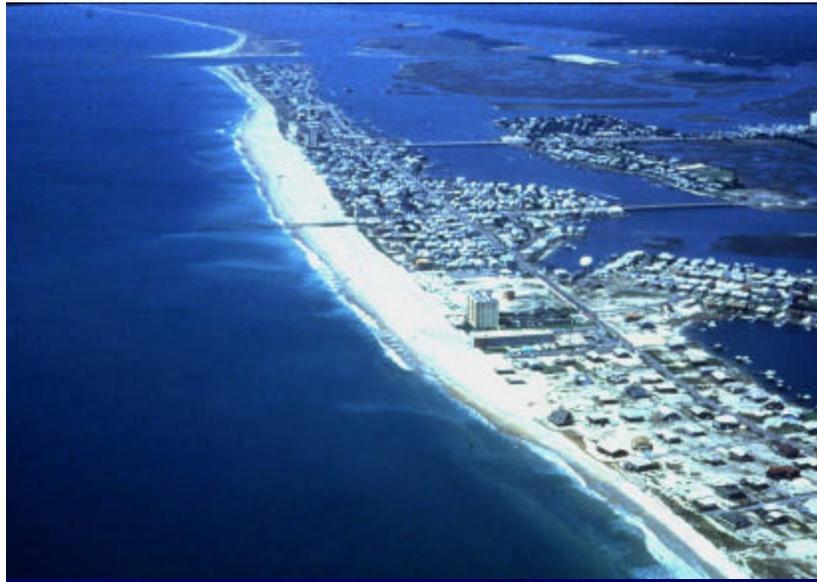
Photo 2-4: Wrightsville Beach Project

marsh, a small island (Harbor Island), and the Atlantic Intracoastal Waterway (see **Photo 2-4**). Masonboro Inlet is in the upper left-hand portion of the photo. The large high-rise structure in the lower mid-portion of the photo is the Islander Condominium. This building is located at the north boundary of the Federal storm damage reduction project. Johnnie Mercer's fishing pier is located in the middle of the photo. The shoreline segment north of the Islander Condominium is

2. Land Area and Incorporation. Significant portions of the counties being examined are unincorporated, though incorporation continues. Incorporated towns and cities in the study area have jurisdiction over some of these unincorporated areas. This is the case with the small areas of Hanby Beach and parts of Wilmington Beach, which fall under Kure Beach's jurisdiction. The remainder of Wilmington Beach is under Carolina Beach's jurisdiction. Surf City just annexed the Onslow County portion of Surf City in 1988, and has had a small amount of unincorporated mainland area under its jurisdiction since 1992. Prior to 1990, North Topsail Beach was an unincorporated part of Onslow County, known as West Onslow Beach. Because North Topsail Beach was incorporated right after the 1990 census was conducted, a limited, special census had to be undertaken. This ongoing process of recent incorporation and extra-jurisdictional territory makes the measurement of demographics even more challenging. Land area and incorporation dates are summarized in **Table 5-1**. Throughout this chapter, the demographics and damages associated with Wrightsville Beach are for the entire incorporated area of town of Wrightsville Beach. This area includes not only the 14,000-foot long ocean front Corps project (from Masonboro Inlet north to approximately Moores Inlet Street) but also includes the northern part of Wrightsville Island (Shell Island), Harbor Island and mainland Wrightsville Beach (see Photo 2-4 and Figure 2-4).

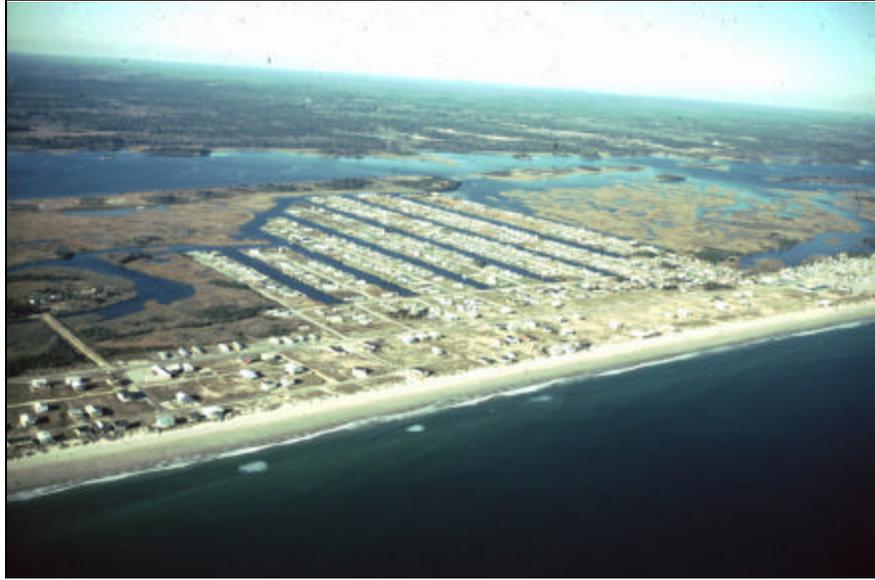
Photo 2-5; Surf City

c. Surf City. Like Topsail Beach, Surf City is a heavily developed resort community (see **Photo 2-5**). This development is also subject to flooding during severe storms and land losses due to beach erosion have occurred. At the time of the 1989 study, however, the shoreline at Surf City was considered generally stable, and had a natural dune system.

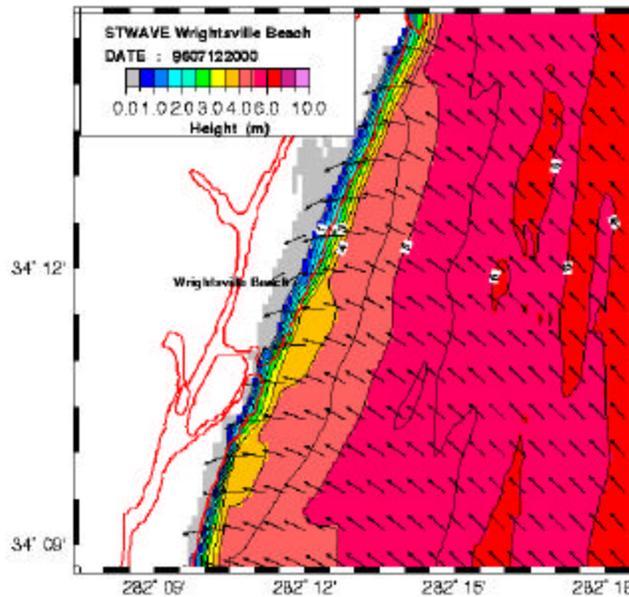
Figure 3C-13: Wrightsville Beach
Significant Wave Height Estimates Contours for Peak Storm Conditions, Hurricane Bertha
(arrows are the vector mean wave direction)

(a). The most severely impacted shoreline reach was at Wrightsville Beach because of the landward migration of the wave estimates caused by the surge.

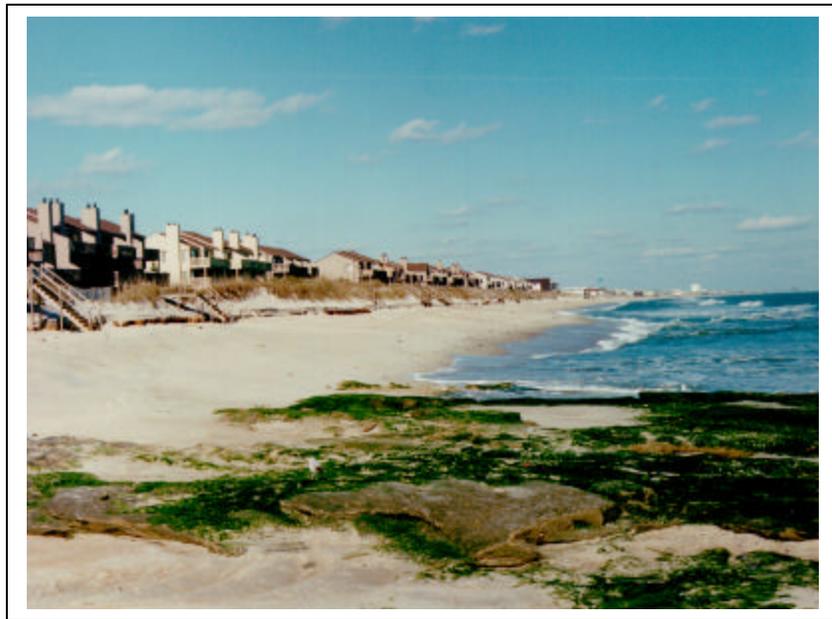
Photo 3D-1: Coquina Rock Outcrop at the Southern end of Kure Beach

to the higher topography, a natural outcropping of coquina rock fronts the southern end of Kure Beach. A picture of the coquina rock outcrop is shown on **Photo 3D-1**. While the outcrop is a visible feature, this geologic formation is known to lie at or near the surface of the ocean bottom offshore of Kure Beach (see Geology, Chapter 4) and, as a result, greatly influences the slope and planform shape of the bottom contours. The presence of the rock and the high elevation of the land mass are both believed to have contributed to the higher water mark elevations in the Kure Beach area. First, the rock formation probably causes some focusing of wave energy resulting in higher waves along some section of the area, particularly in the area of the visible outcrop. Second, the high land mass could result in a partial standing wave along the area that would allow water trapped inside buildings to leave a higher water mark. Regardless of the cause, the phenomenon appears to be real, as high water marks left following Hurricane Bonnie in 1998 and Floyd in 1999 along Kure Beach were also higher than the high water mark elevations observed along neighboring beaches. Whatever the reason, the elevation of the high water marks along Kure Beach averaged 14.0 feet above NGVD, the highest of all the areas included in the post-storm study area.

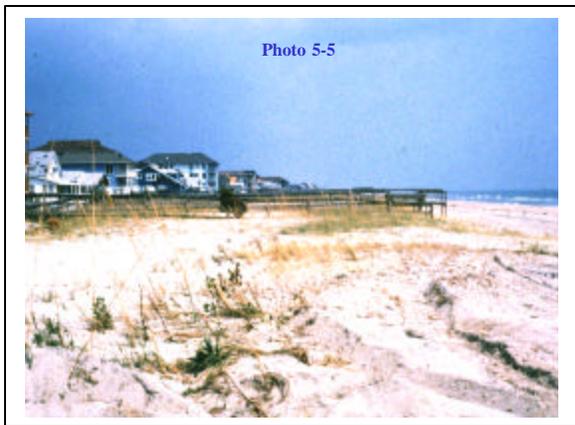
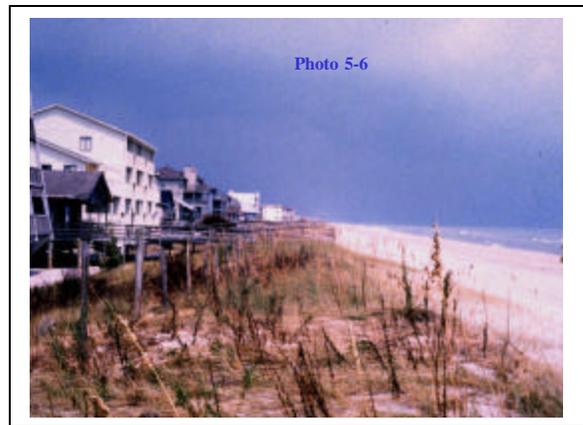
Photos 5-5 and 5-6; Carolina Beach after Fran

b. Carolina Beach. Structural damage behind the beach fill portion of the protection project fronting Carolina Beach was limited to that caused by wind, rain, and flooding from the sound side. Also, some floodwaters entered the town from the north around the north end of the rubble revetment as well as wave overtopping of the revetment. While the storm surge elevation combined with the accompanying storm waves generally overtopped the dune, the only significant impact of this was the deposition of sand inside the lower floors of ocean front buildings and along the road paralleling the ocean. There was essentially no wave impact damage. Not only did the ocean front structures escape serious damage; the dune walkover structures were not damaged. **Photos 5-5 and 5-6** show the typical condition of Carolina Beach following Hurricane Fran. In Photo 5-5, which was taken in the vicinity of the Boardwalk business area, dune overtopping is evidenced by sand ripples in the dune. In spite of this overtopping, the dune

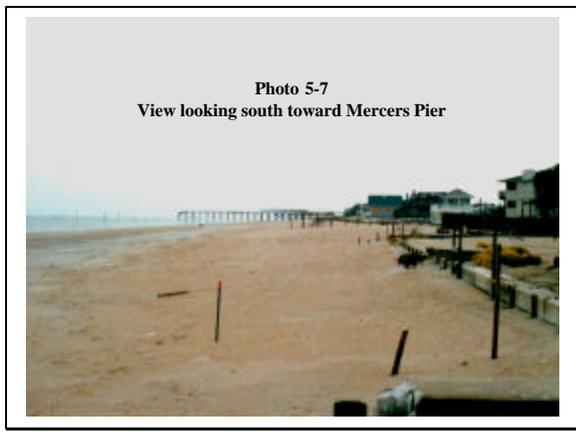
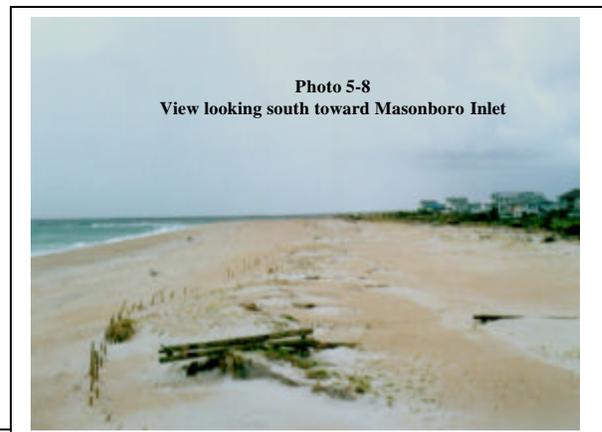
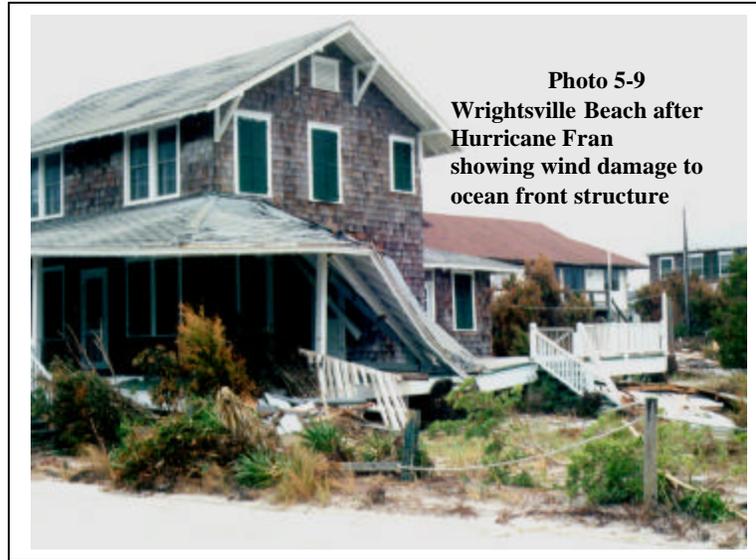
Photos 5-7, -8, and -9; Wrightsville Beach after Fran

Photo 5-9
Wrightsville Beach after
Hurricane Fran
showing wind damage to
ocean front structure

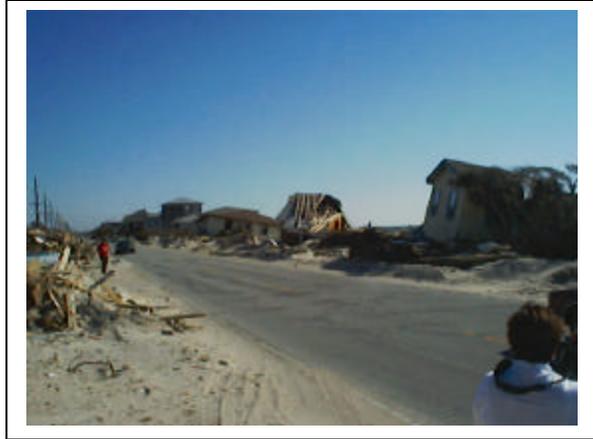
Photo 5-10; Town of Topsail Beach after Fran

(1). Damages. Prior to Hurricane Fran, most of Topsail Island was fronted by a vegetated natural dune with the exception of the southern 2-miles, which had a small man-made dune formed by scraping sand off the beach, and portions of North Topsail Beach, which also was protected by a man-made dune. Even though a dune did exist along most of the island, there was very little dry beach fronting the dune during normal high tide. Hurricane Bertha, which hit the area in mid July 1996, severely weakened the dunes. Hurricane Fran, which occurred eight weeks later, completed the job, destroying all of the man-made dunes along Topsail Beach and North Topsail Beach. Hurricane Fran also destroyed most of the natural dunes with the exception of approximately 2.5-miles of shoreline in the Town of Surf City where the landward portions of the dunes still remain. Hurricane Fran caused extensive erosion of the shoreline, rendering a majority of the ocean front lots unbuildable and caused extensive structural damage to ocean front structures as well as structures located on the second and third rows from the ocean. Examples of the types of damage experienced along Topsail Island are shown on **Photos 5-10** for the Town of Topsail Beach, **5-11 and 5-12** for the Town of Surf City, and **Photos 5-13 to 5-16** for the Town of North Topsail Beach.

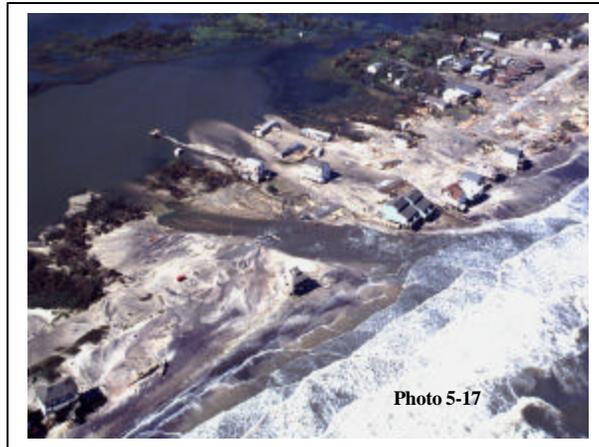
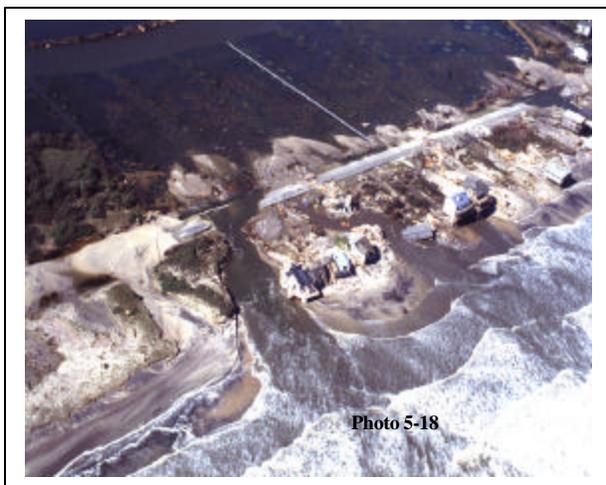
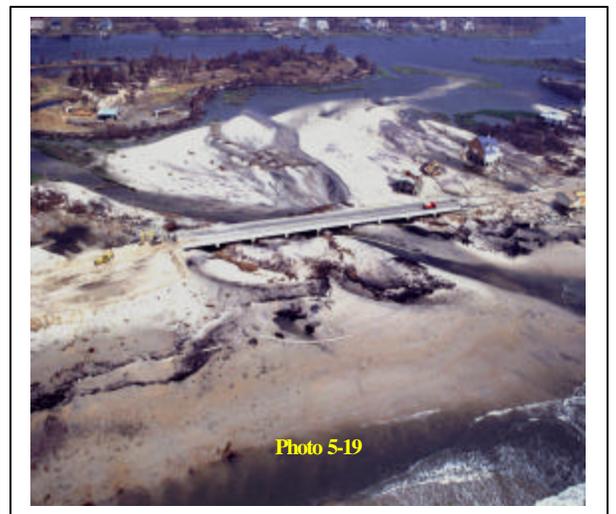
Photo 5-17, -18 and -19; Breaches at North Topsail Beach following Fran

(2). Island Breaches. In addition to the damage to the dune and beach system, Hurricane Fran breached the island in approximately five locations, resulting in the creation of temporary inlets. Emergency work performed by the North Carolina Department of Transportation and the natural recovery of the beach resulted in closure of four of the breaches within a few weeks following the storm. However, the fifth breach, which was located approximately 2-miles south of New River Inlet, remained open for almost a year following Hurricane Fran. **Photo 5-17 and 5-18** show two of the smaller breaches that occurred along North Topsail Beach. **Photo 5-19** shows the northernmost and largest breach. All three photos of the island breaches were made within a few days following the storm. Several of the breaches along North Topsail Beach, including the northernmost breach shown on Photo NTB-7, occurred in low areas which

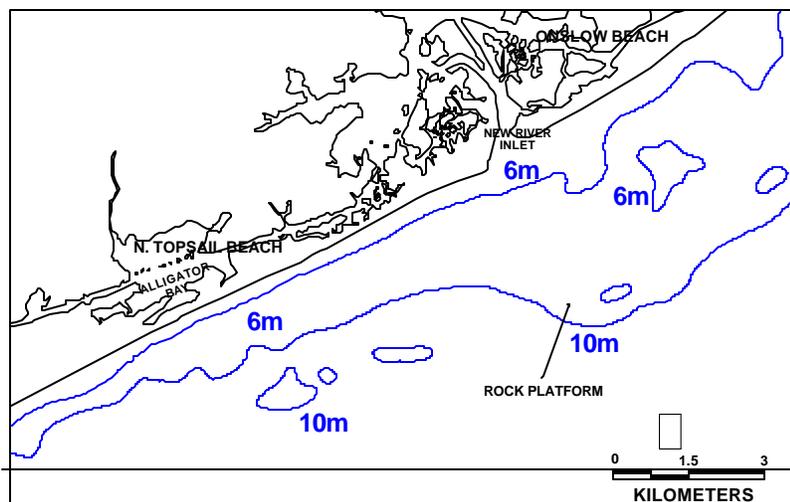
Figure E-6: Bathymetric Map of North Topsail Beach and New River Inlet

Bathymetric map of the area around North Topsail Beach and New River Inlet. Note platform-like feature that occurs off the inlet and the excursion of the contour lines. This feature influenced the shoreline conditions and processes throughout the Holocene and Pleistocene.

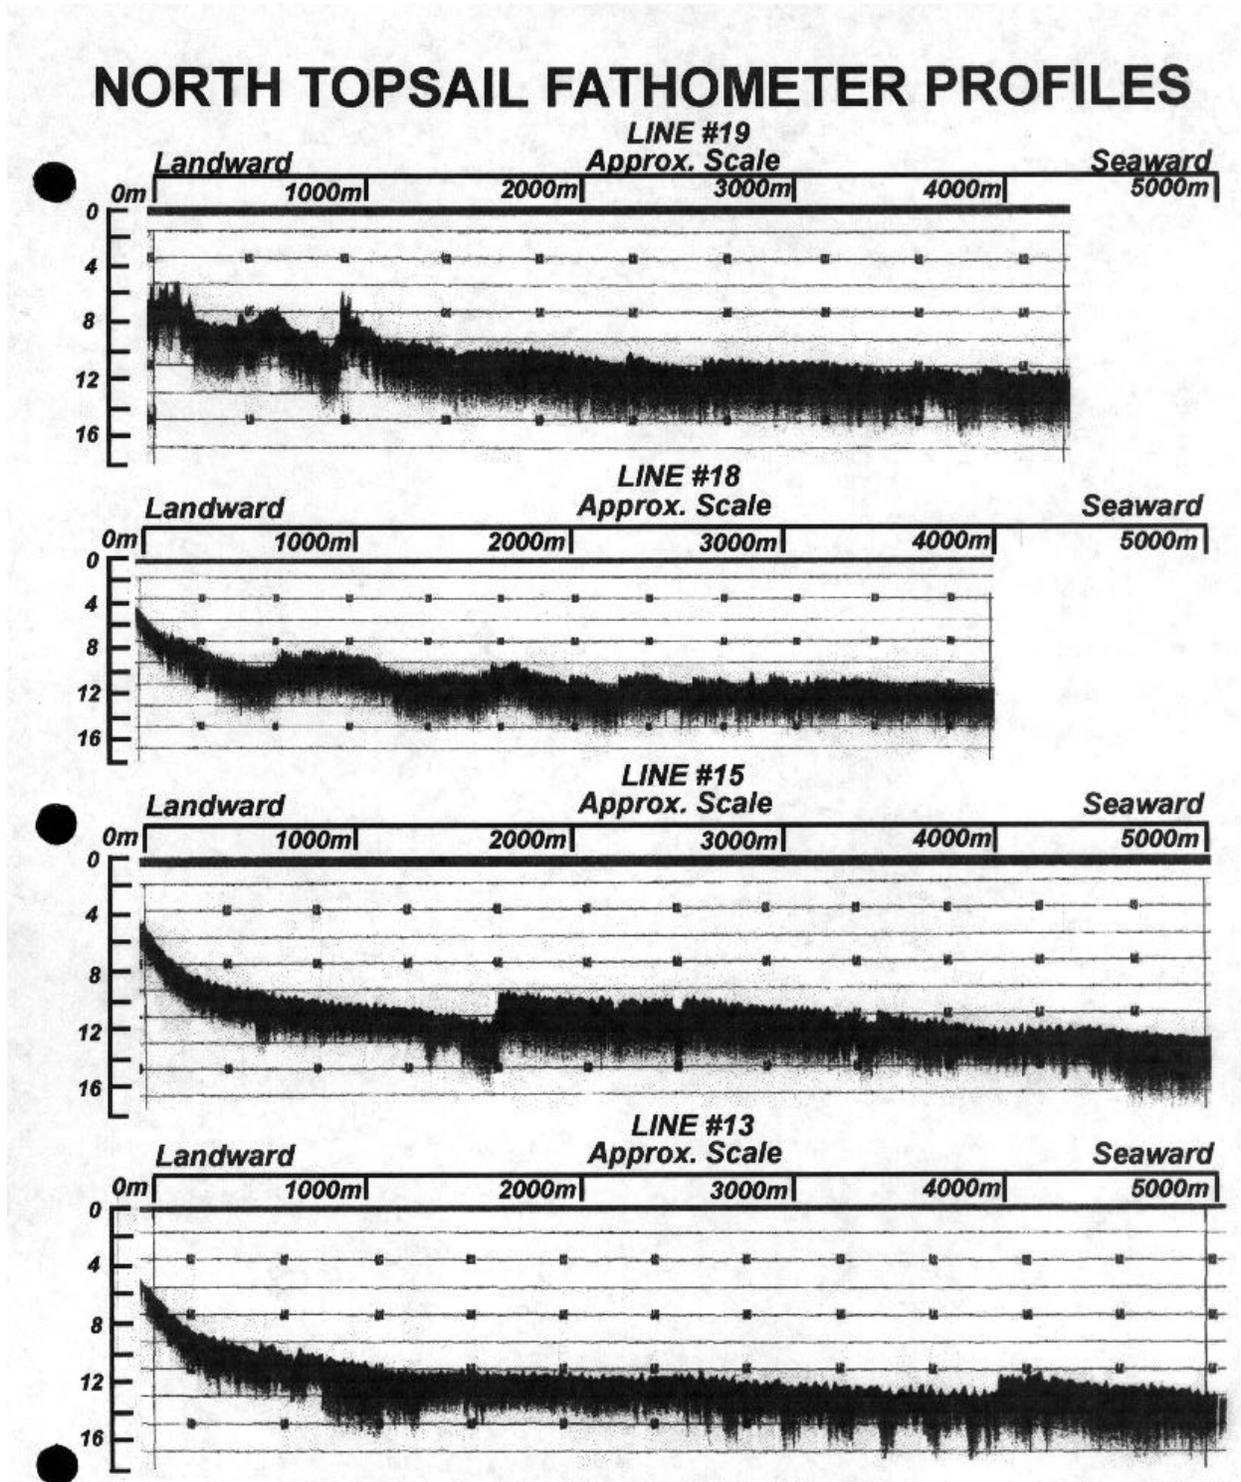
Figure E-8: Fathometer Profiles off North Topsail Beach

Figure 8. Representative fathometer profiles off North Topsail Beach. Note the many scarps that play a role in the cross-shore movement of sediment. See Figure 2 for locations of profiles.

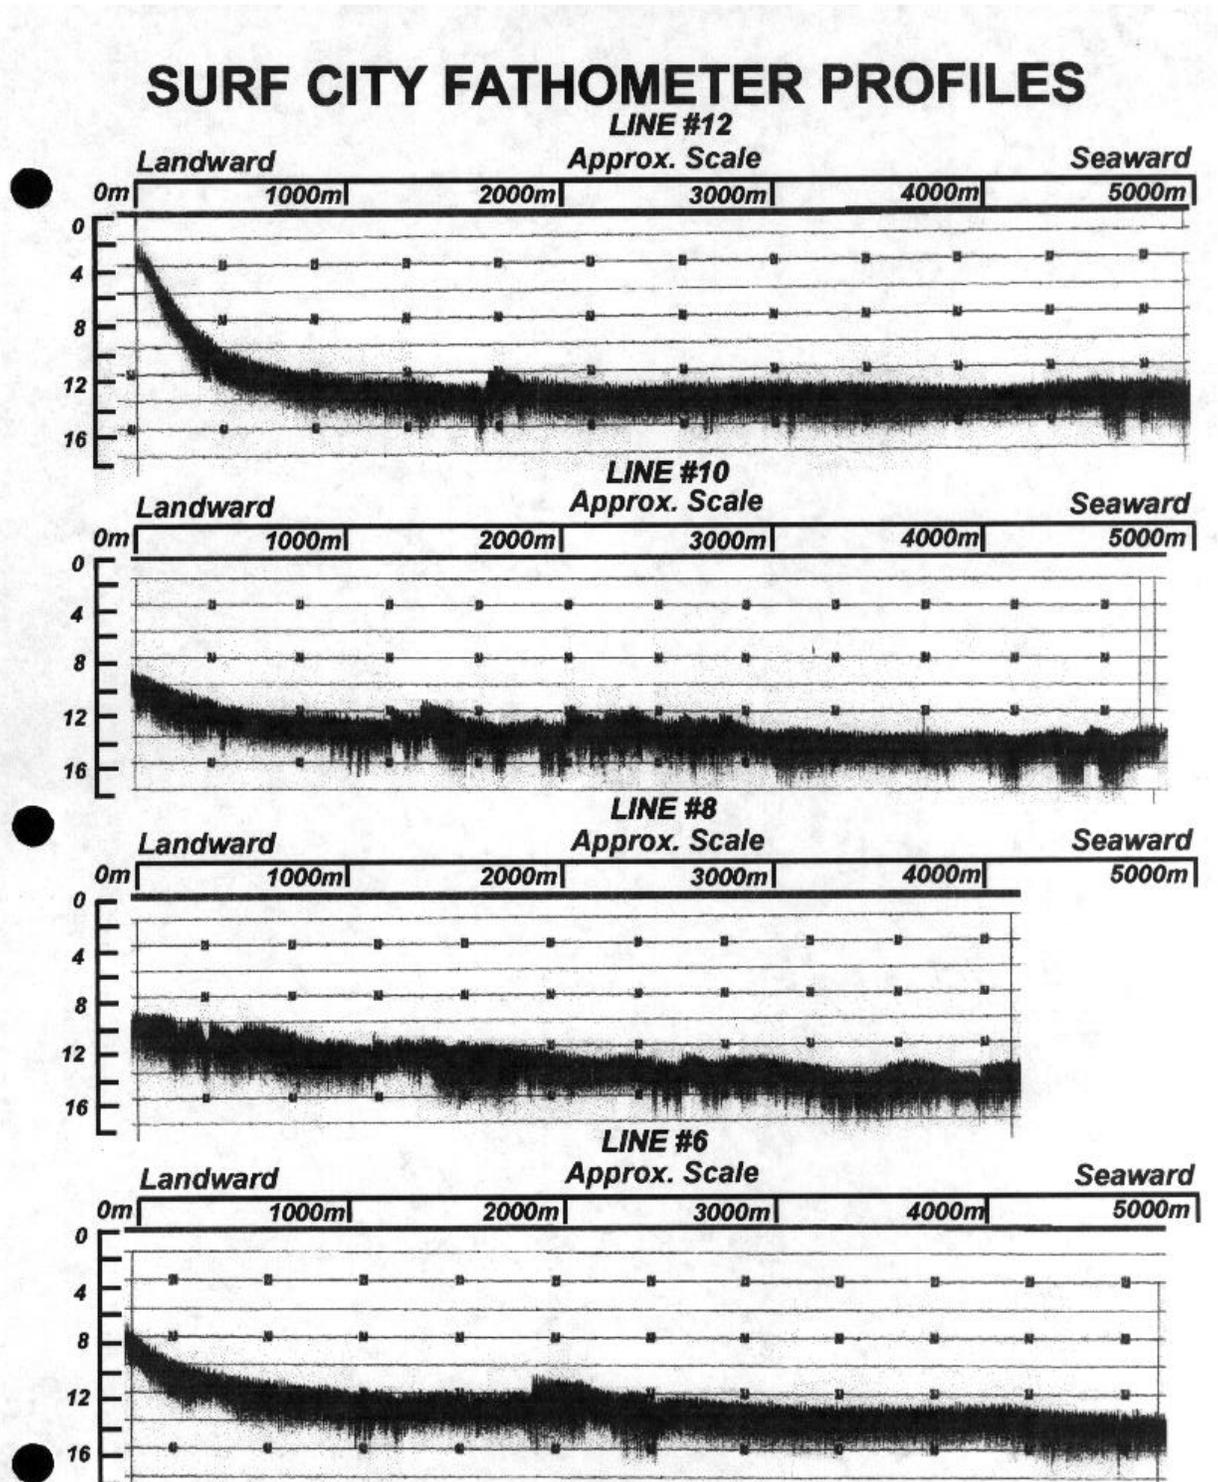
Figure E-12: Fathometer Profiles off Surf City

Figure 12. Fathometer profiles off Surf city. See Figure 11 for locations. Lines 6-12 show evidence of multiple scarps and hardbottoms. Most scarps are landward facing and often fronted by sediment aprons.

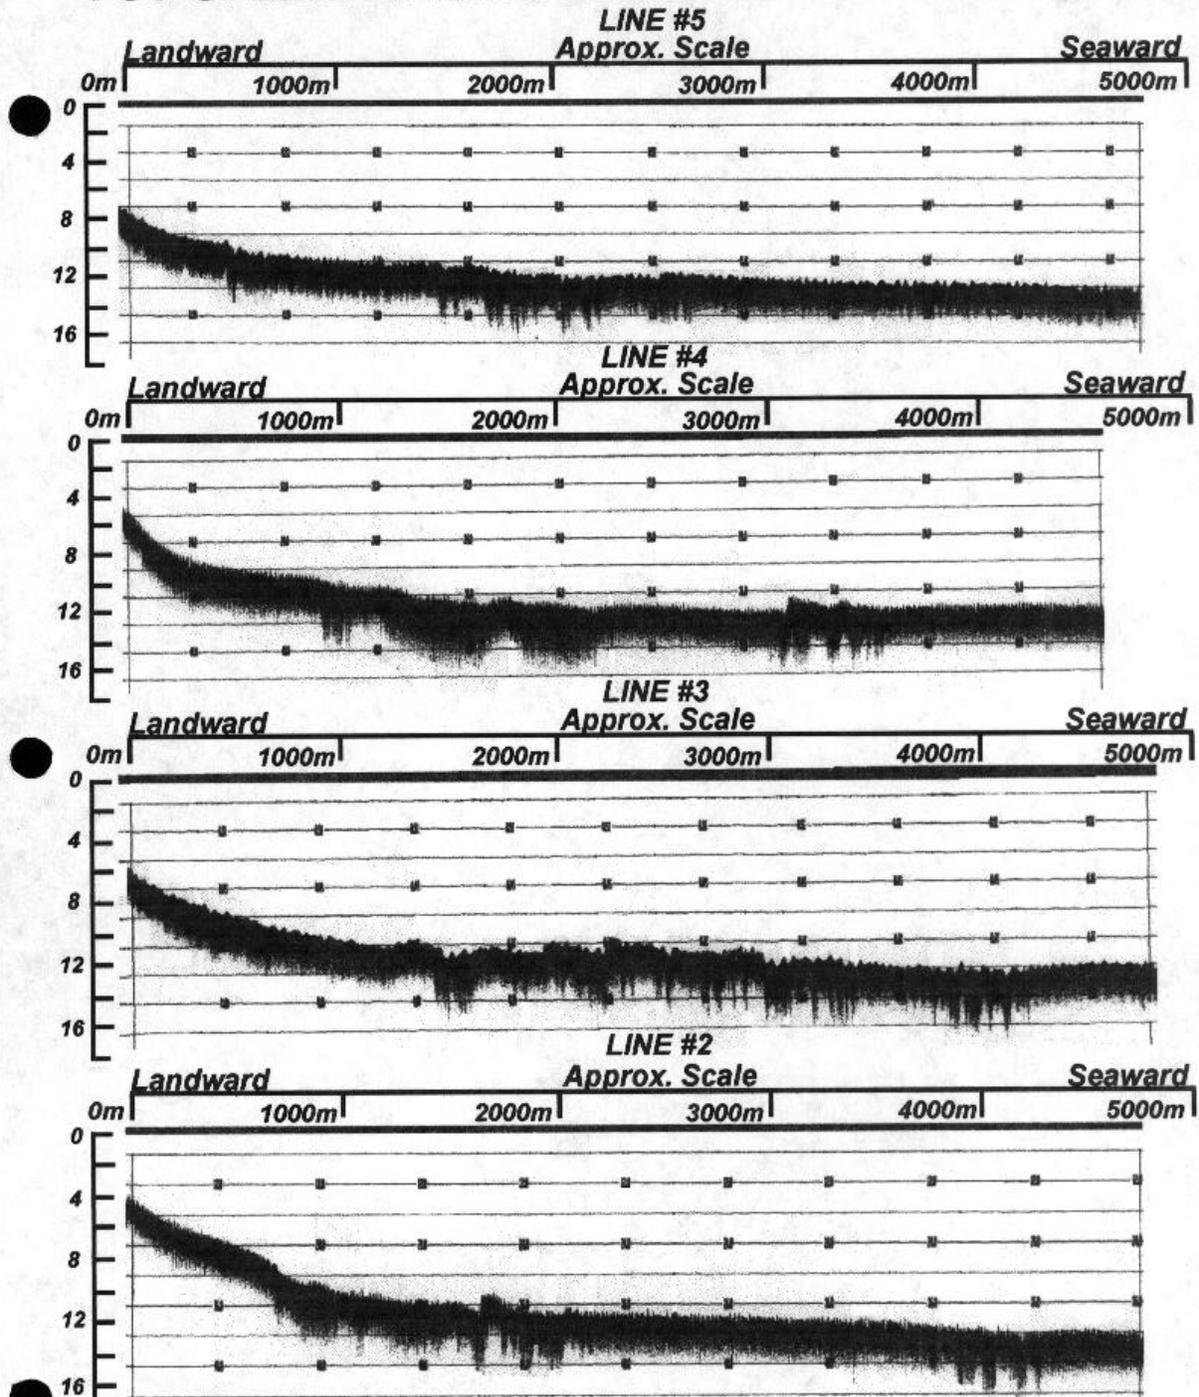
TOPSAIL BEACH FATHOMETER PROFILES

Figure 14. Fathometer profiles off Topsail Beach. Much of the area is blanketed by a thin layer of silty quartz sand. Hardbottoms are generally low relief.

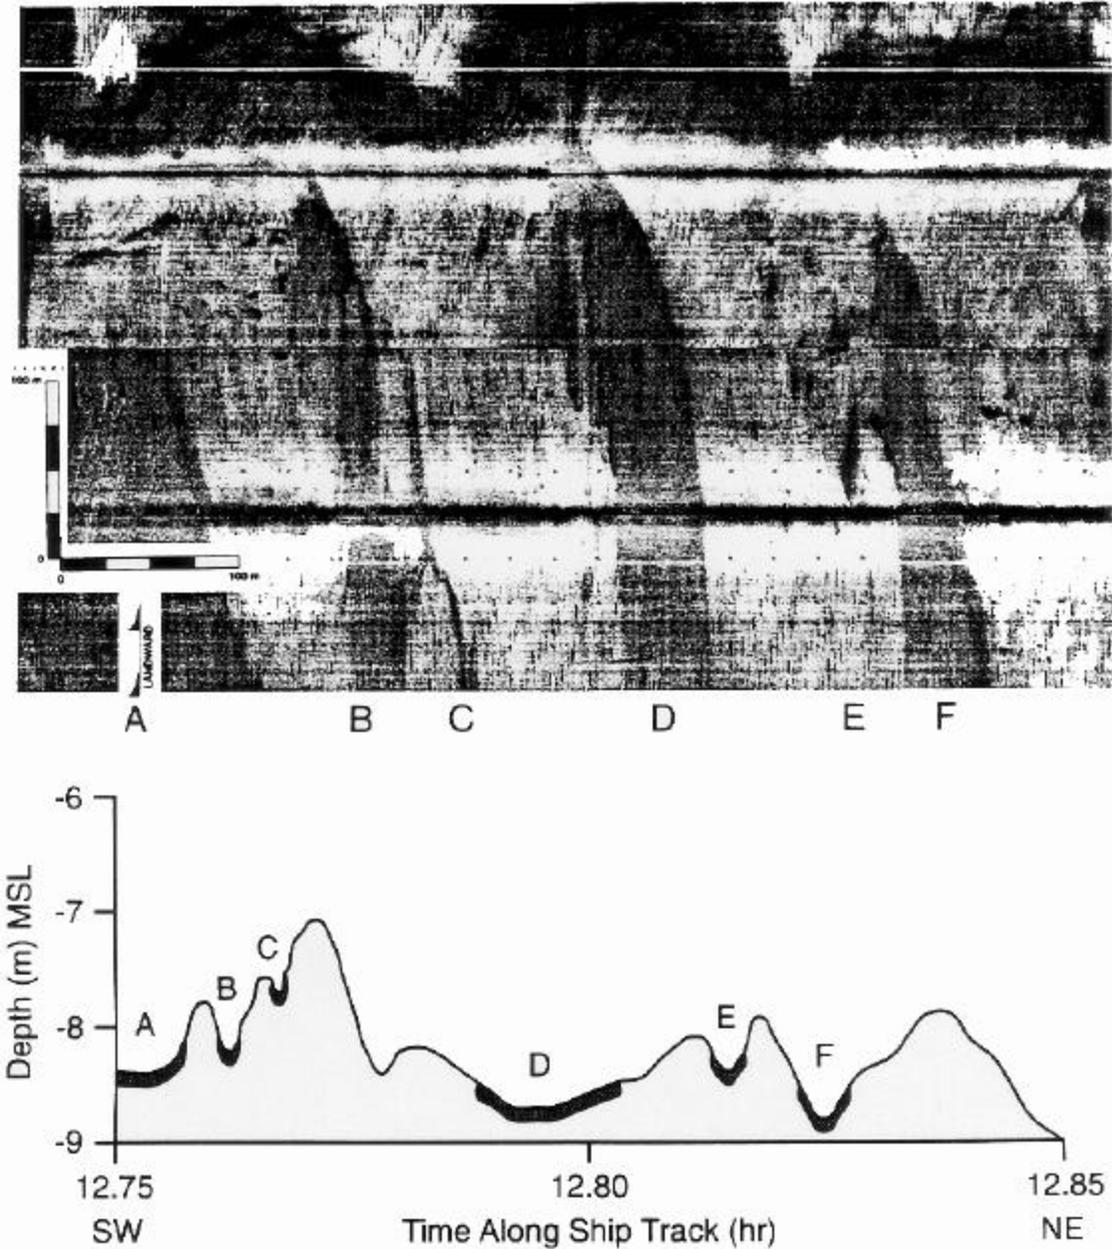
Figure E-16: Illustration of Overlapping Shore-parallel Sidescan Sonar Images

Illustration showing overlapping shore-parallel sidescan sonar images depicting rippled scour depressions (A-F) that lie immediately seaward of the surf zone. Coarse sediments are imaged as dark colored regions on the sidescan swaths and are contained within the topographic lows. Lighter areas are fine sands. Irregular dark patches within the lighter colored areas represent hardbottoms. Depressions are generally shallow with maximum relief of less than 1.0m. Most of the trough-like areas extend to the base of the shore =face (after Thieler et al, 1995).

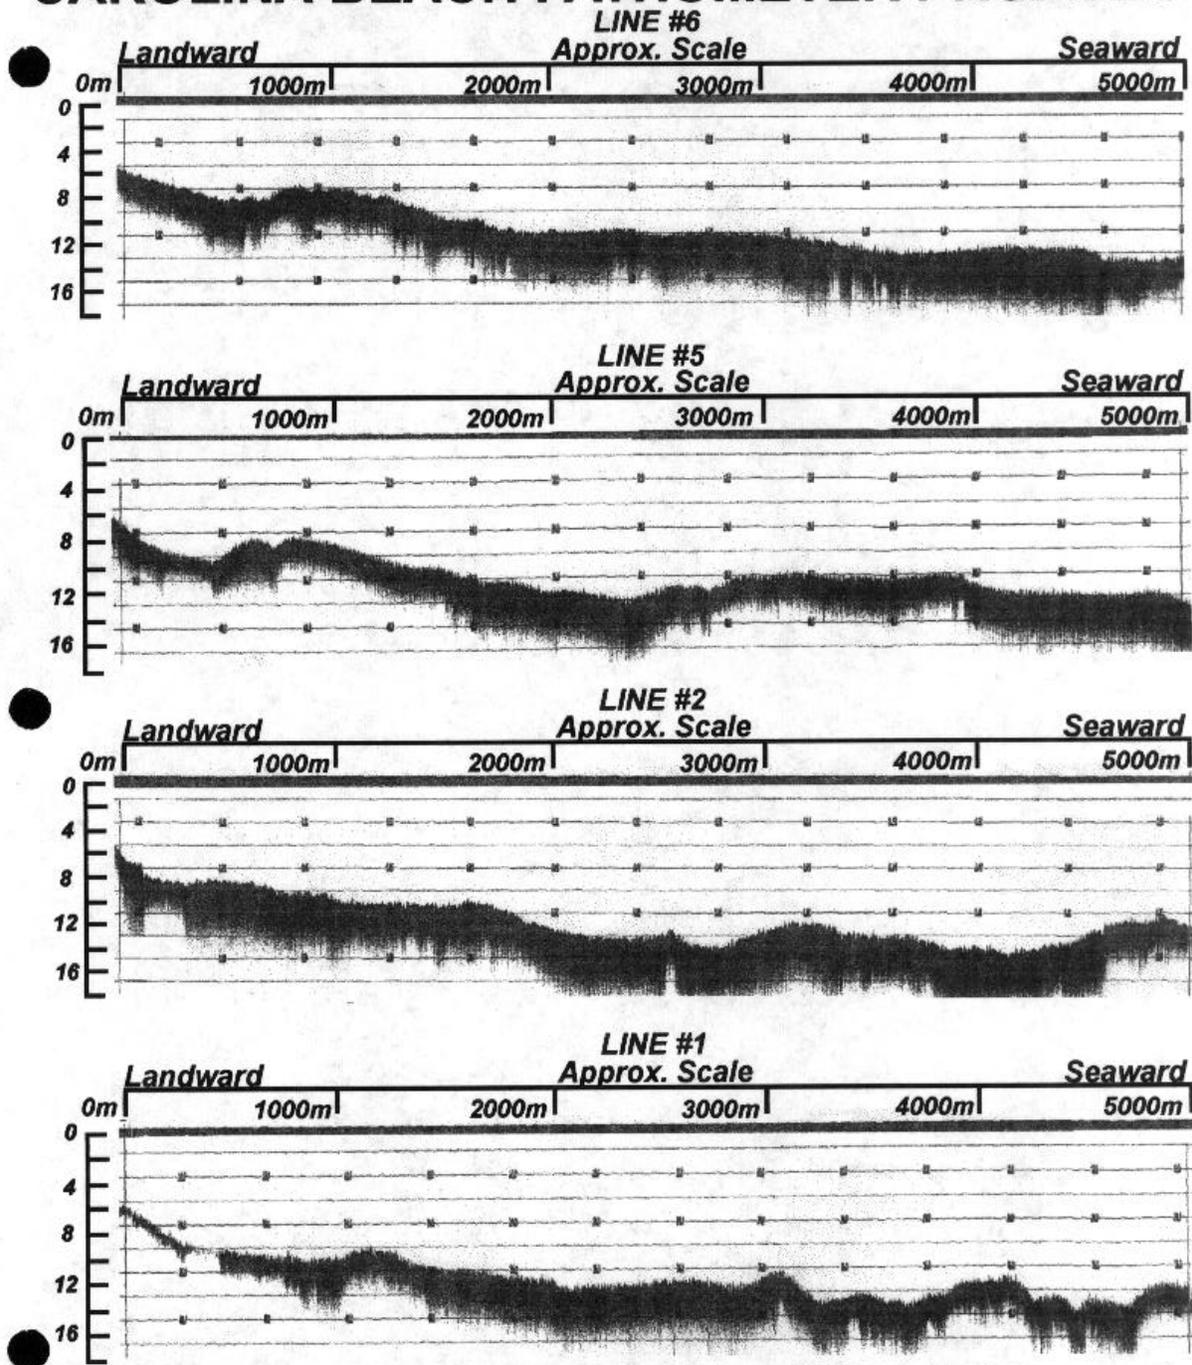
CAROLINA BEACH FATHOMETER PROFILES

Figure 19. Fathometer profiles off Carolina Beach. Broad bathymetric highs are related to the presence of shore attached ridges and extensive hardbottoms.

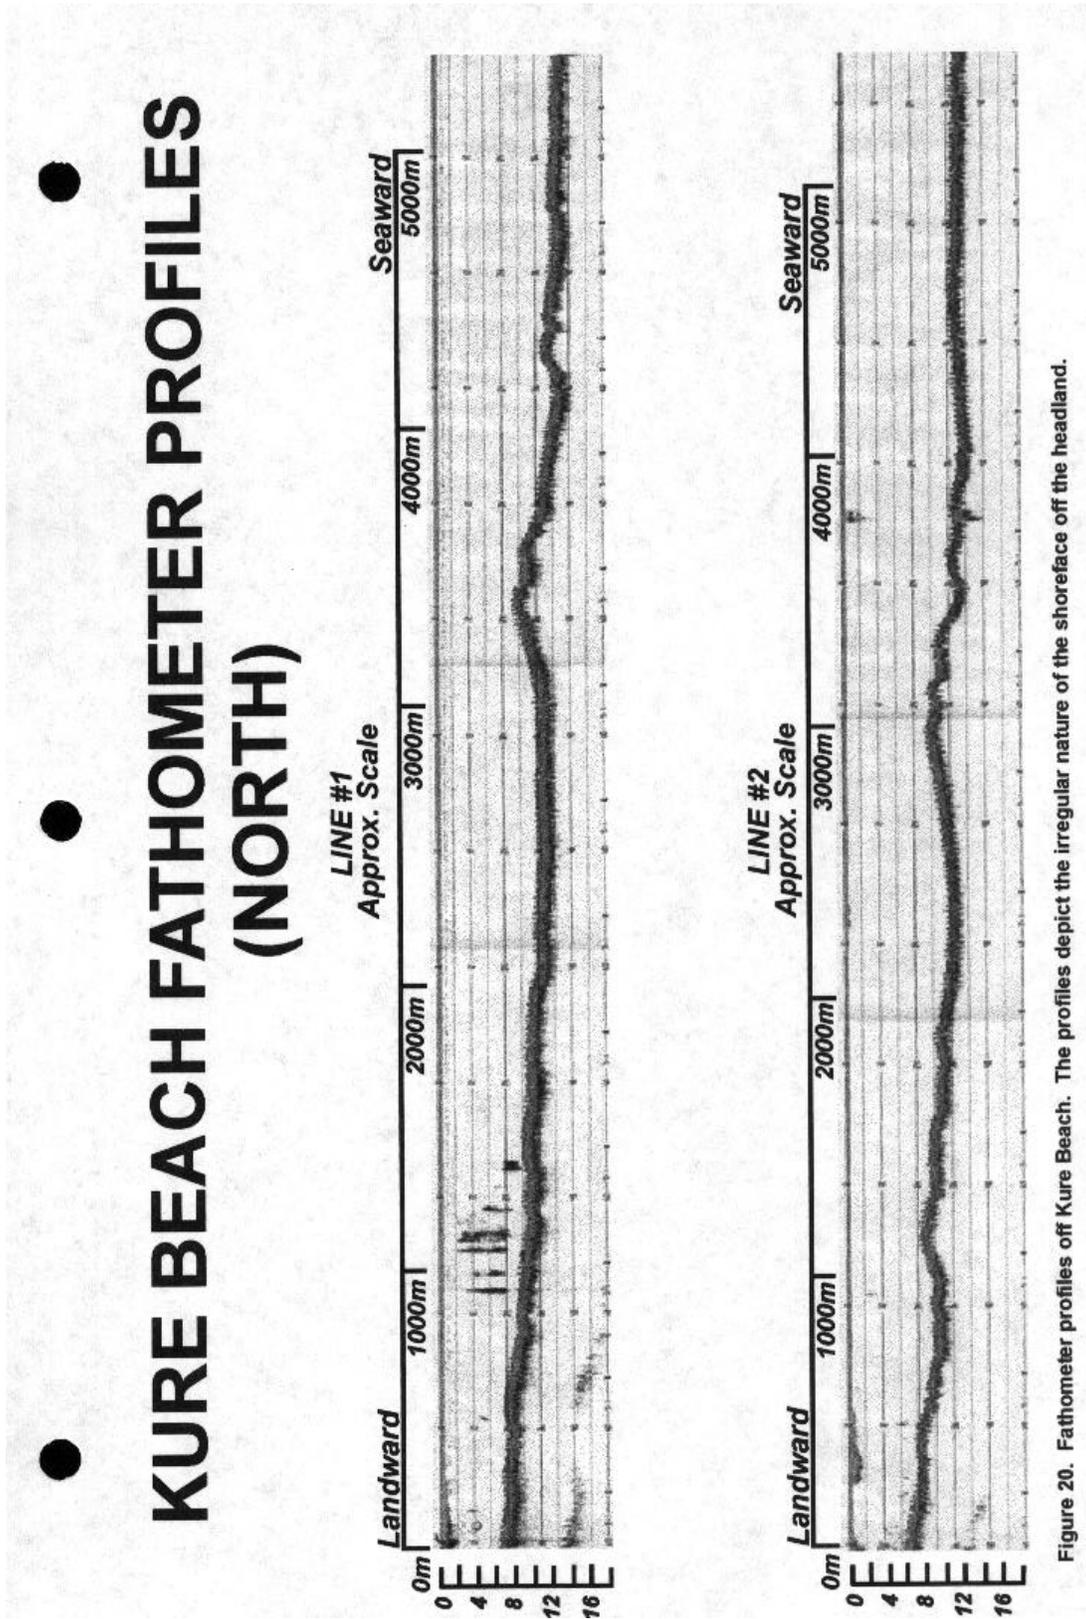
Figure E-20: Fathometer Profiles off Kure Beach (North)

Figure 20. Fathometer profiles off Kure Beach. The profiles depict the irregular nature of the shoreline off the headland.

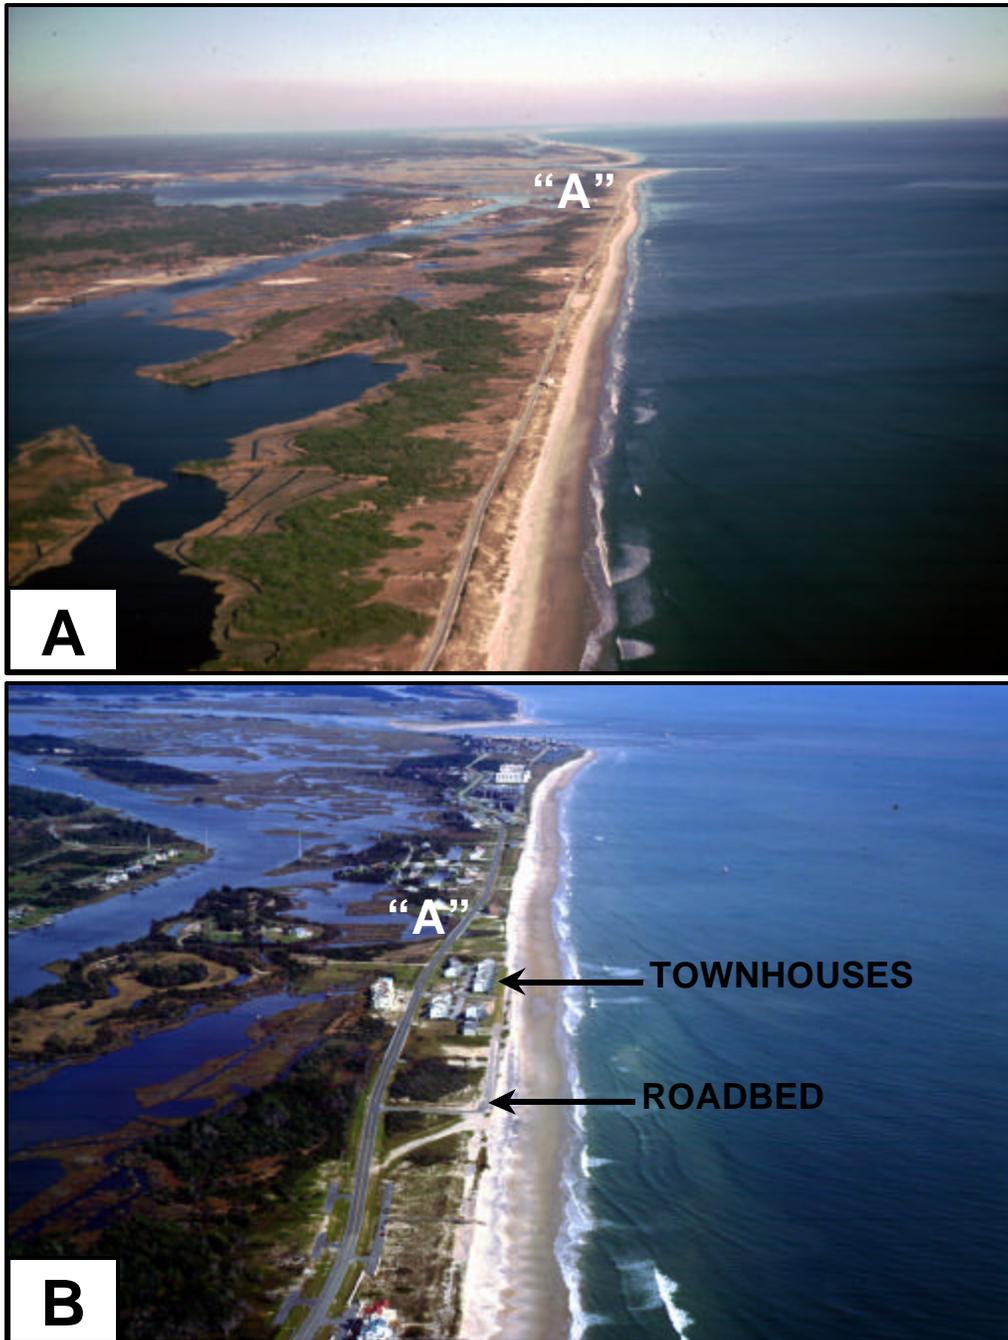
Plate E-1:

Plate 1. Oblique aerial photographs of North Topsail Beach. A.) North view (December 1974) showing position of old road, scaped dunefield, vegetated washover terraces. Note lack of development. Shoreline protuberance at north end of island is due to the presence of New River Inlet. B.) North view of northern portion of North Topsail Beach (November 1995). The road pictured at "A" was relocated in the early 1990's. Portions of the old roadbed are visible in some areas (arrow). Note lack of dunes and scaped grasslands along much of this section of the barrier.

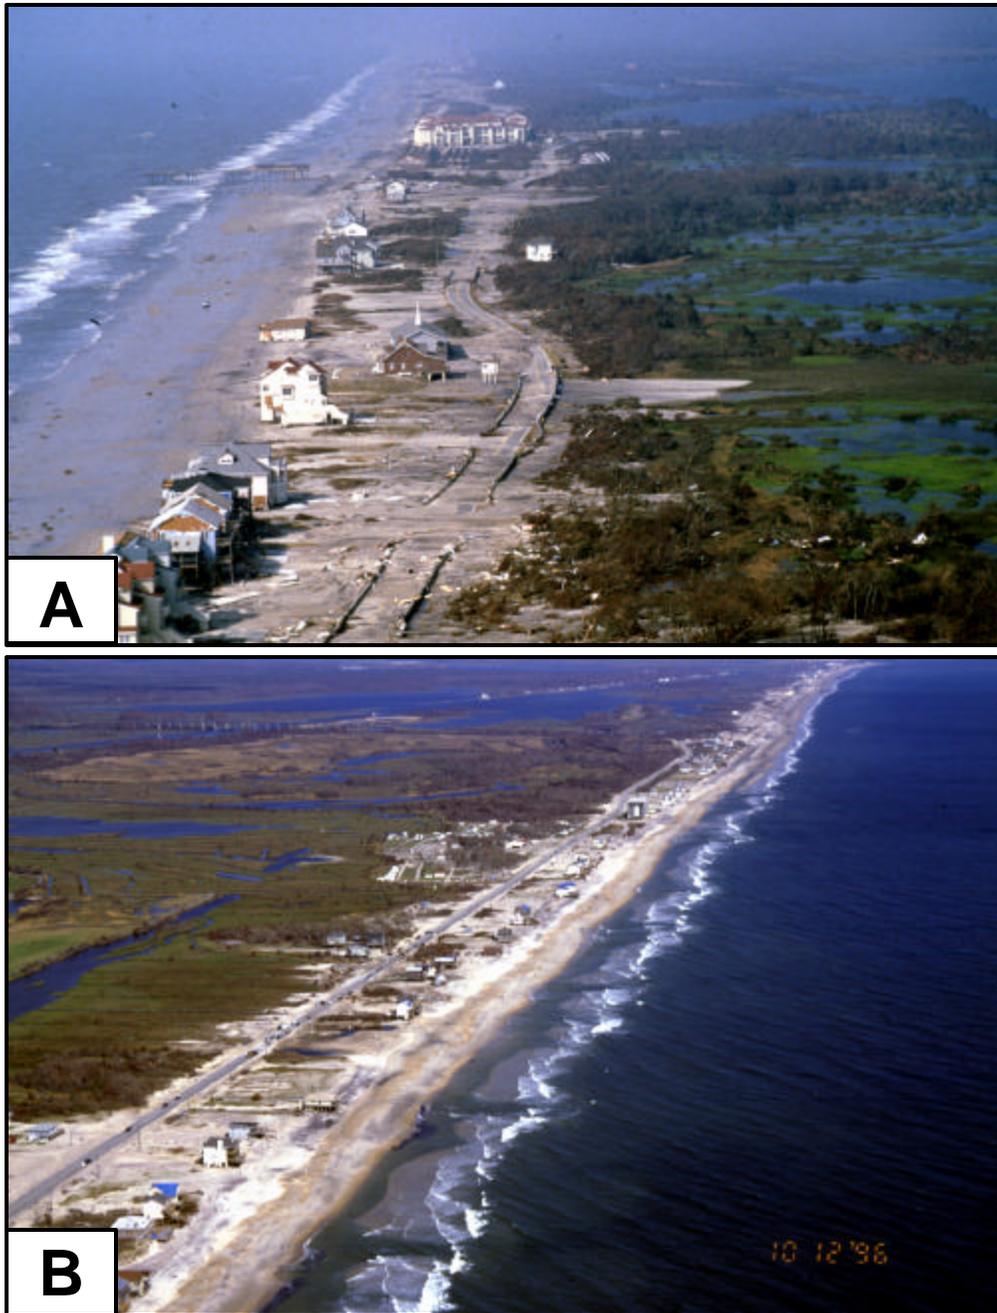
Plate E-3:

Plate 3. Oblique aerial photographs of the southern portion of North Topsail Beach after Hurricane Fran (September 6,1996). A.) South view of extensive washover terraces, note only scattered segments of grasslands remain. Most topographic lows were infilled with washover materials. B.) North view from region just south of high rise bridge. Washover terraces extend across entire island in most regions. Note scattered outcrops of peat.

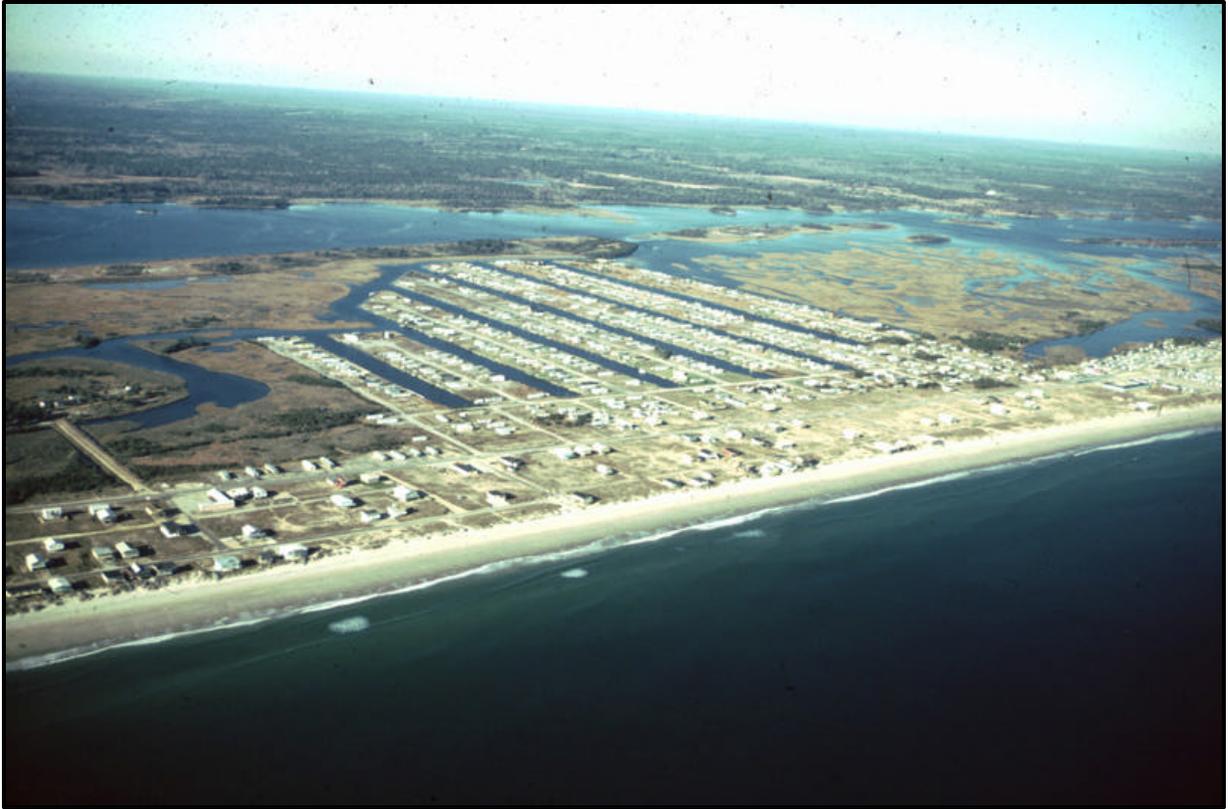
Plate E-4:

Plate 4. Landward view of Surf City (12/75) showing vegetated flood tidal delta and the extensive development along the low lying finger canals. Note the nature of the dune line and dune field.
