HURRICANE FRAN EFFECTS ON COMMUNITIES
WITH AND WITHOUT SHORE PROTECTION:
A CASE STUDY AT SIX NORTH CAROLINA BEACHES

IWR Report 00-R-6

December 2000

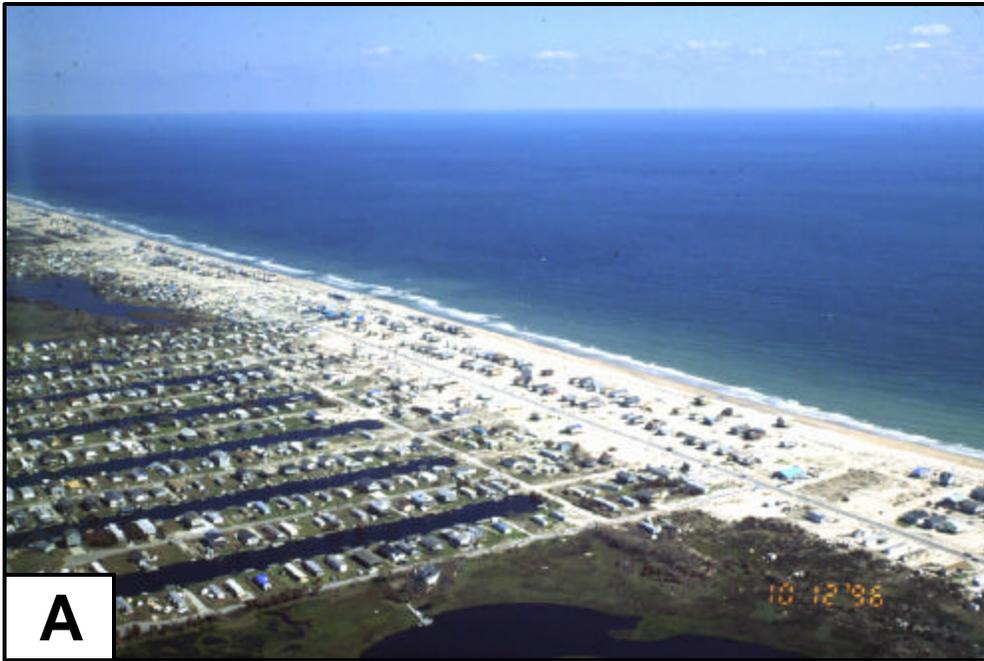
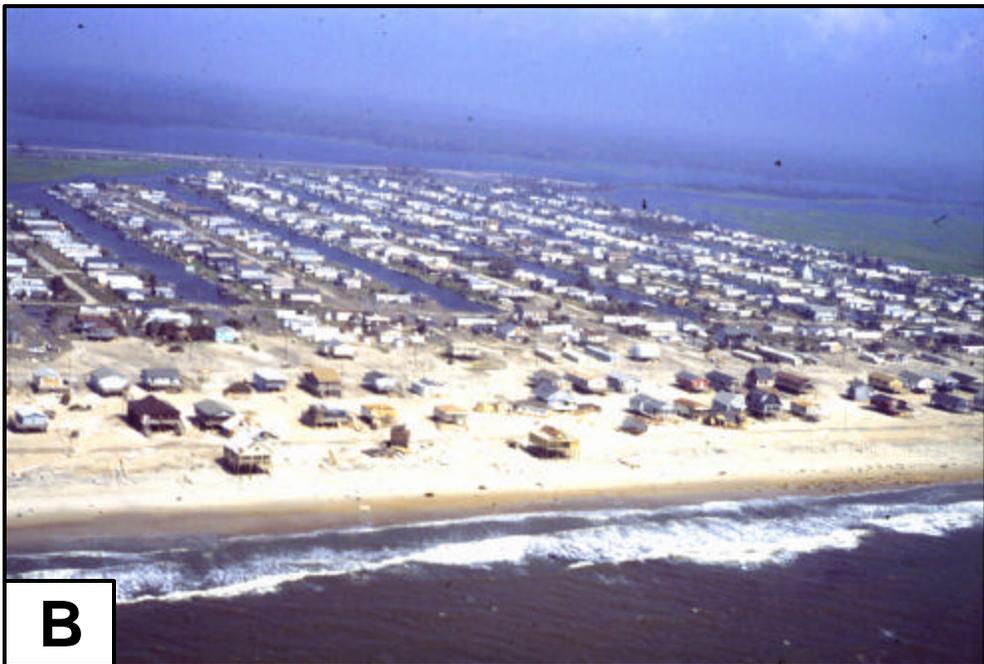
Plate E-5:

Plate 5. Post Hurricane Fran views of Surf City (10/12/96). A.) Seaward view of low area fronting old tidal delta and extensive washover terraces. A number of structures were destroyed along the shoreline segment in the center of the photograph. B.) Landward view of the same area in "A", 0.5 to 1.0m of washover sediment covered the roadbed along much of this section of the town. Note the structural damage along this section of the beach.

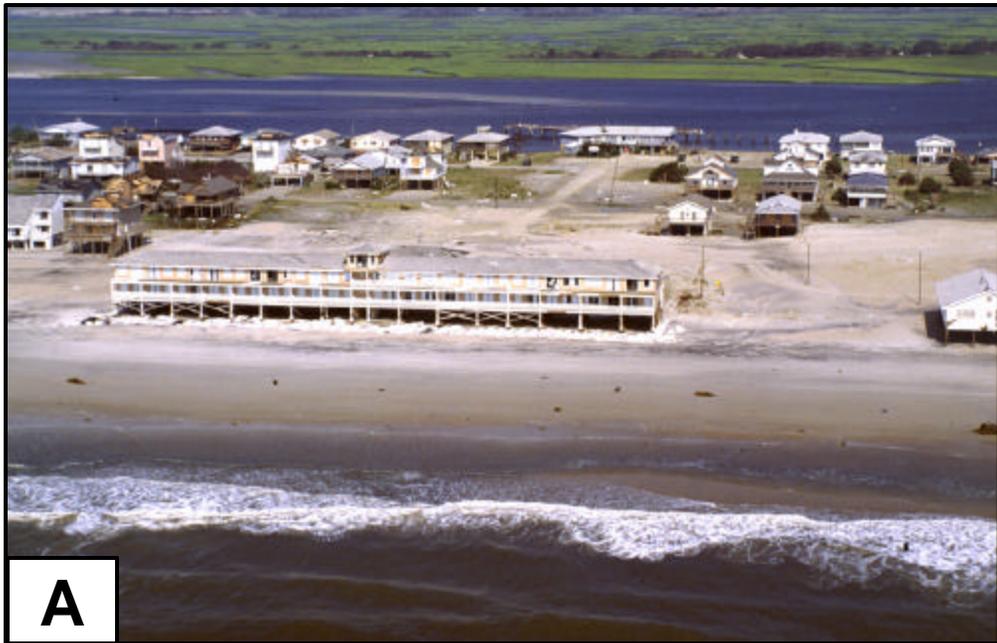
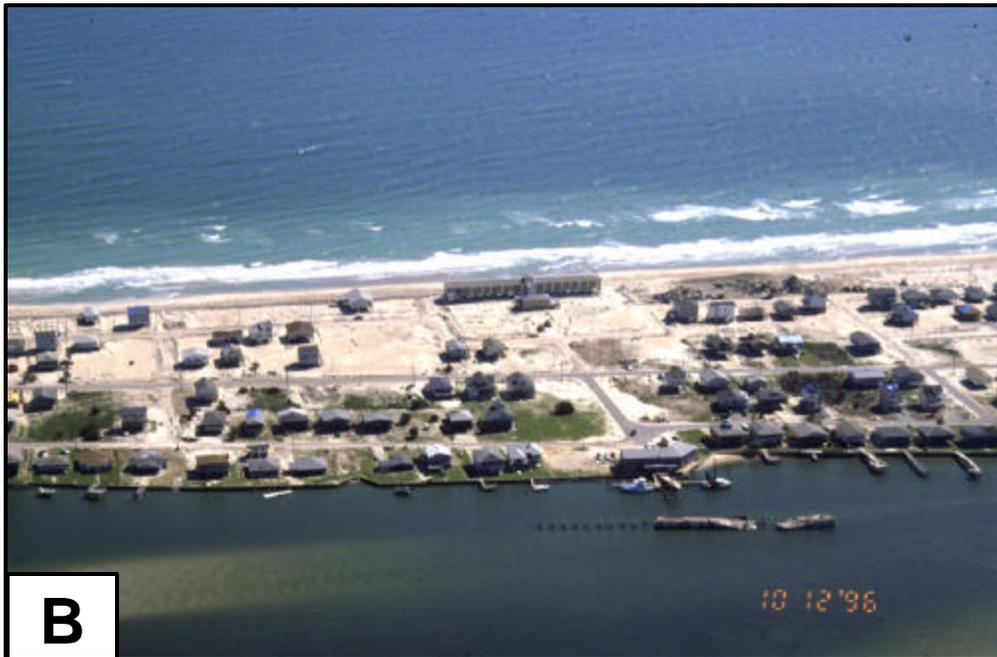
Plate E-6:

Plate 6. Post Hurricane views of Topsail Beach. A.) Sea Vista Hotel along the southern portion of the area is surrounded by an extensive washover terrace that extended beyond the third row of homes (9/7/96). B.) Seaward view of the same area in "A" (10/12/96). Sand has been scraped into a low dune-like feature along most of the southern end of the area. Note the extensive washover terraces developed in this area.

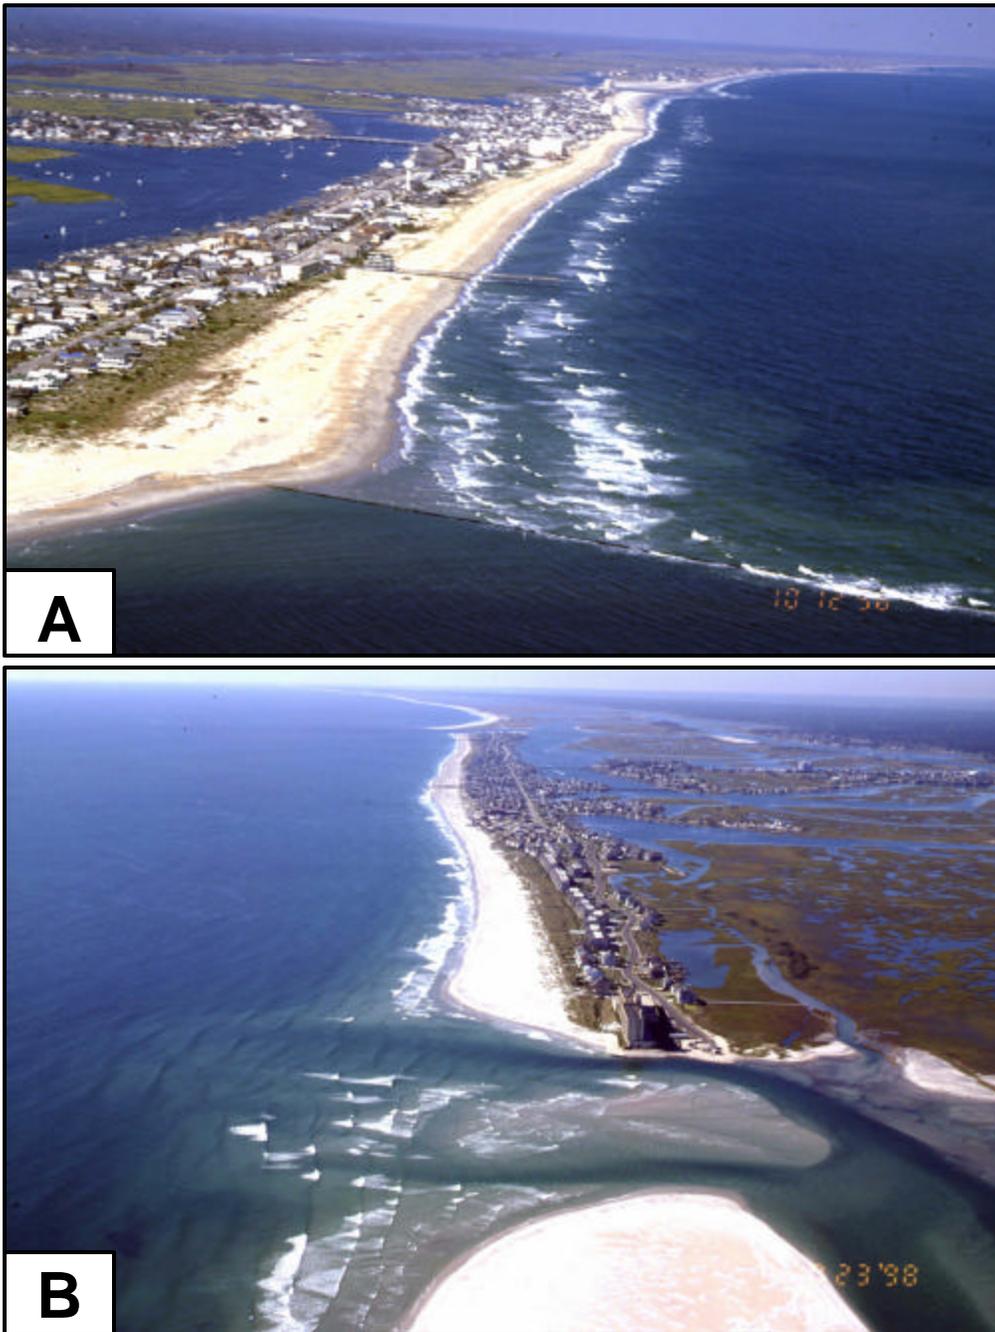
Plate E-7:

Plate 7. Views of Wrightsville Beach. A.) North view (10/12/96) showing fillet developed in the lee of the jetty and the shoreline protuberance along the mid-barrier section. B.) South view of the island (9/23/98) illustrating the shoreline bump in the vicinity of Moore's inlet (now closed) and the offset in the building line along this section of the shoreline. Mason's Inlet forms the northern border of the barrier. Sand bags form the downdrift shoulder along the Shell Island Resort in an effort to protect the resort from the rapidly migrating inlet. Note the accretion zone along the oceanfront south of the inlet.

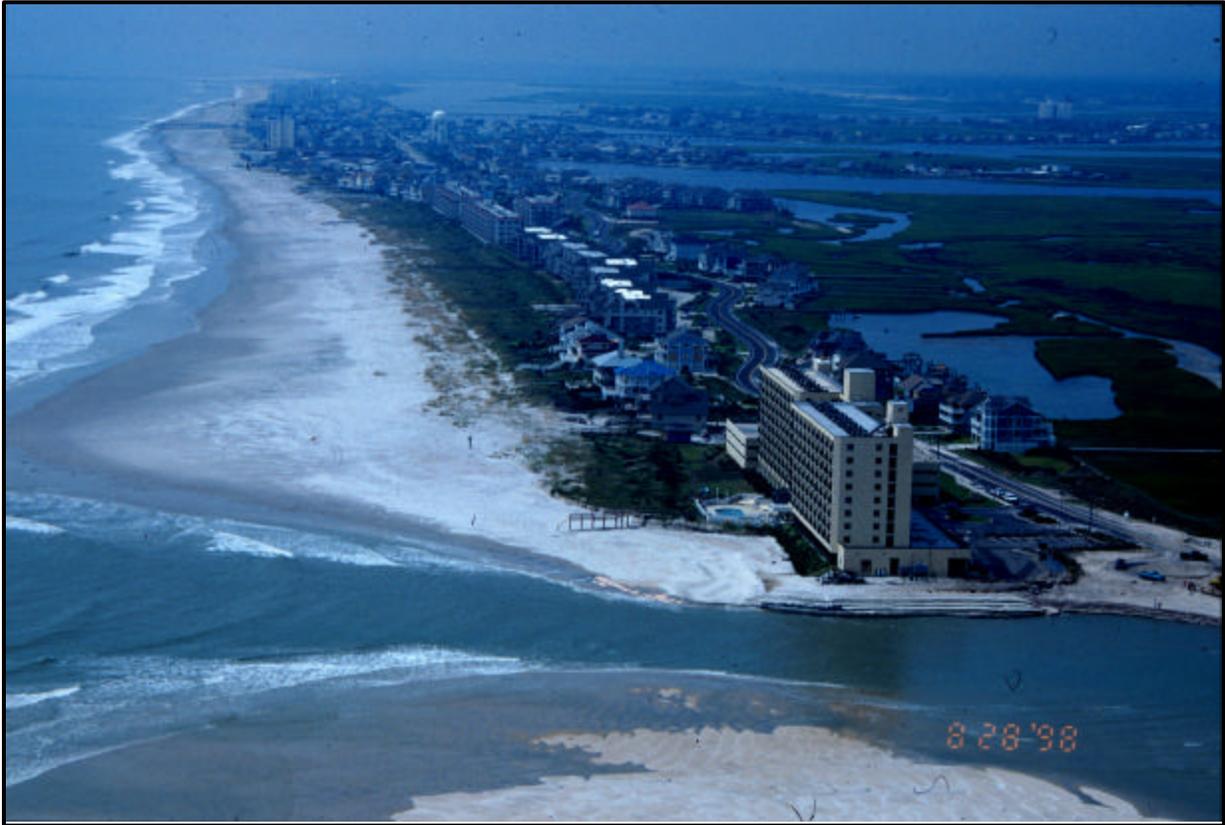
Plate E-8:

Plate 8. South view of Wrightsville Beach after Hurricane Bonnie (8/26/98) and the bump in the shoreline along the mid-barrier section. Note the variations in position of the homes and large multi-unit dwellings along the beach. Most of the chronic erosion and structural damage that is associated with storm events is restricted to this high hazard zone.

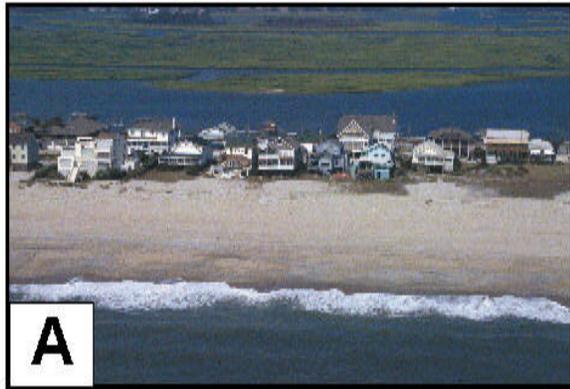
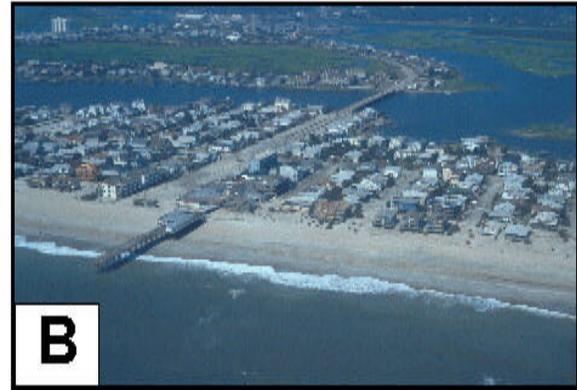
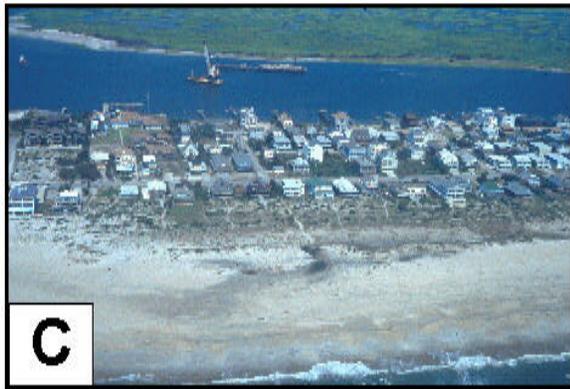
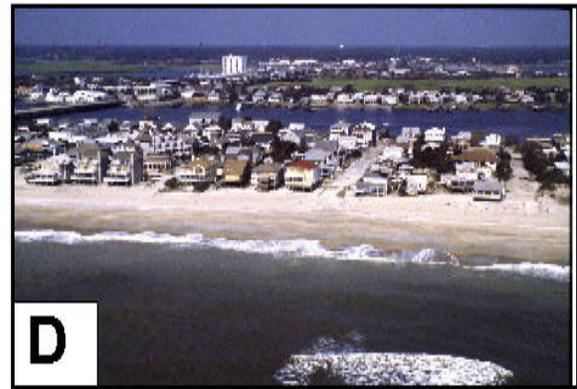
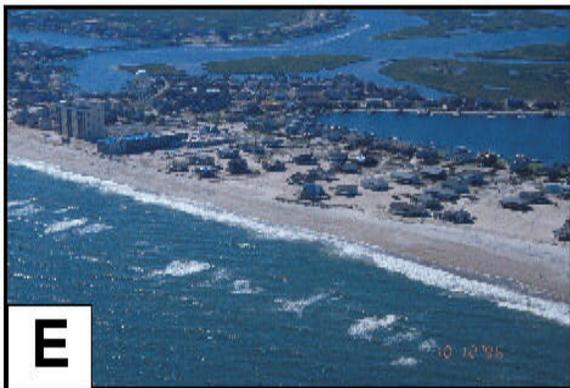
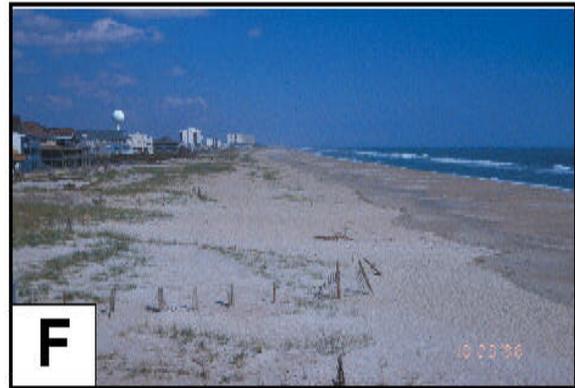
Plate E-9:

Plate 9. Post storm views of Wrightsville Beach. A.) Landward view of south central portion of beach. Little structural damage occurred in this area. Localized overwash is evident. B.) Landward view of shoreline in vicinity of Mercer's Pier. Shoreline north of the pier was susceptible to overwash and minor structural damage was reported in the area. C.) Landward view of prograded shoreline segment near jetty. Little damage was reported in this area due to the wide and high dune field. Localized dune erosion and overwash is evident. D.) Landward view of shoreline south of Mercer's Pier. Minor overwash and minimal damage occurred along this section. E.) Landward view of shoreline in the vicinity of Old Moore's Inlet. The shoreline in this vicinity was the site of the worst structural damage and erosion on Wrightsville Beach due to the poor condition of the beach along the "shoreline bulge". F.) North view of artificial dune/beach almost two months after Hurricane Fran impacted the area. Much of the dune remained in place. Minor washover features are seen along the intact dune.

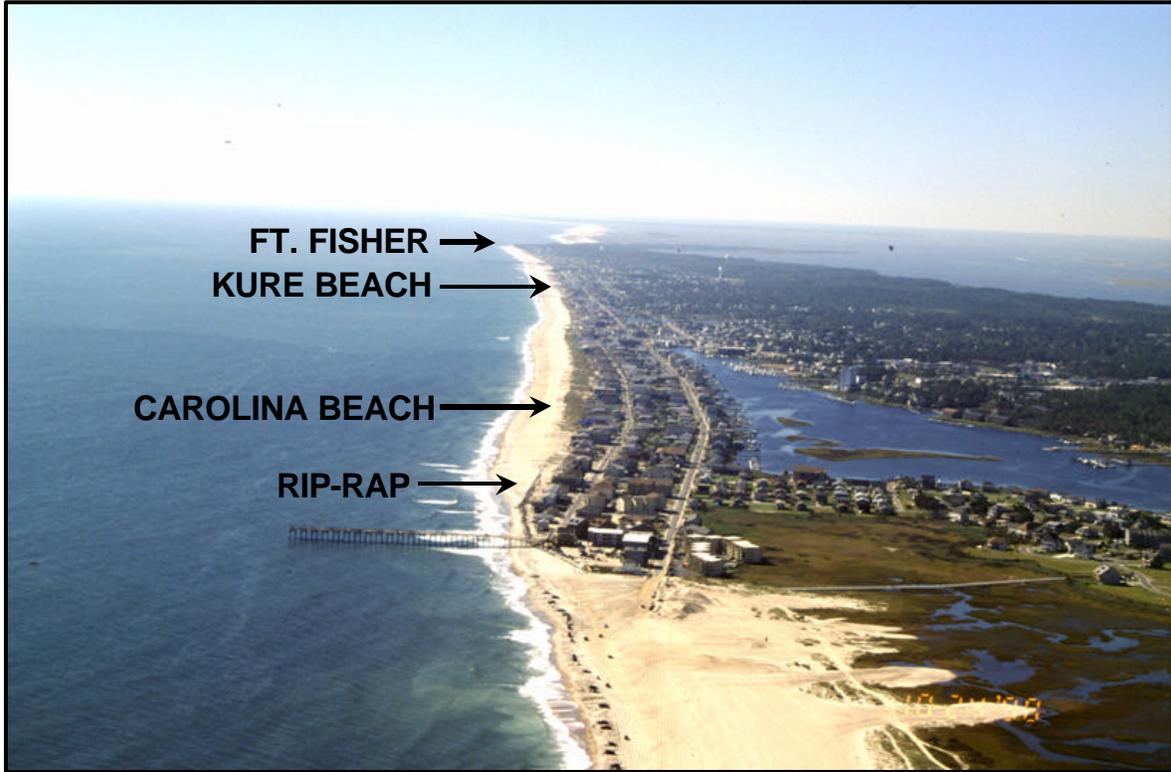
Plate E-10:

Plate10. South view of Carolina Beach and local environments (10/24/98). Note the lagoon narrows and terminates at the headland portion of Carolina Beach. The chronic erosion and overwash susceptible zone is located at the bottom of the photo. The shoreline stretch south of the pier was most heavily impacted by the hurricanes of 1996. Remnants of the washover features are still visible two years later.

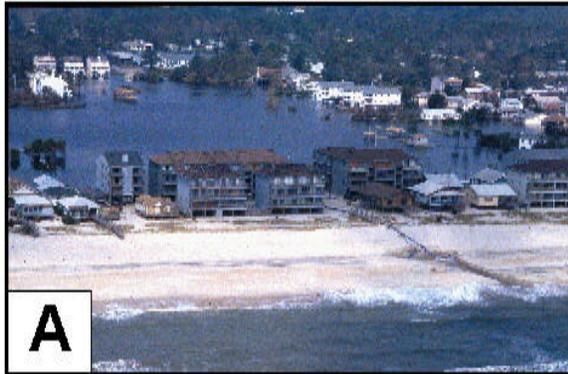
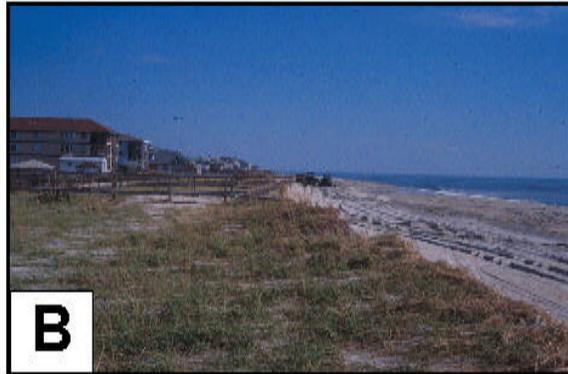
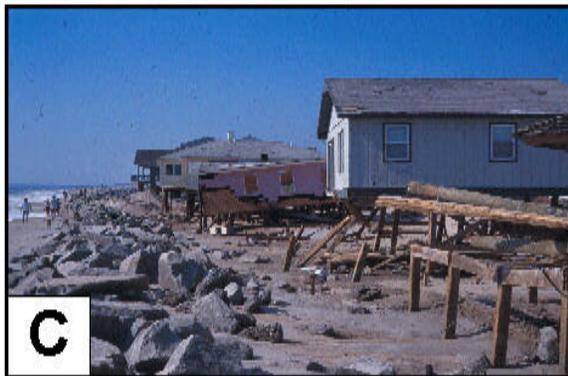
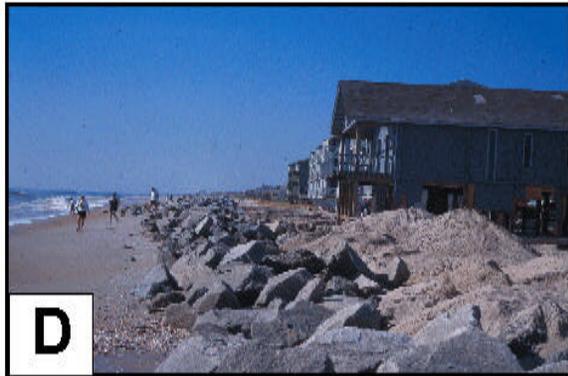
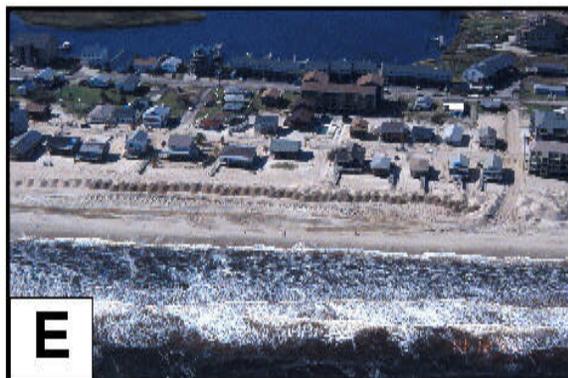
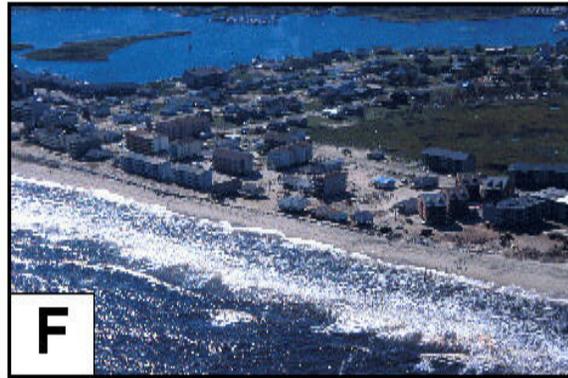
Plate E-11:

Plate11. Post storm views of Carolina Beach. A.) View of Carolina Lake showing eroded dune and flooding of the low -lying area that was once an inlet/lagoon system. B.) North view of eroded artificial dune near the north end of Carolina Beach. Overwash extended across the dune in several places. Damage was minimal. Bulldozing of the profile was common. C.) South view of structural damage near rip-rap at north end of Carolina Beach. D.) Structural damage south of rip-rap was minimal. Overwash extended across the dune and rocks in this area. E.) Air view (10/12/96) one month after Hurricane Fran struck the area. Washover materials were scraped from the roads and placed along the berm/dune system. This area was the site of extensive washover fans. F.) South view of area depicted in "E". Areas not protected by the dune/berm system were overwashed and prone to structural damage.

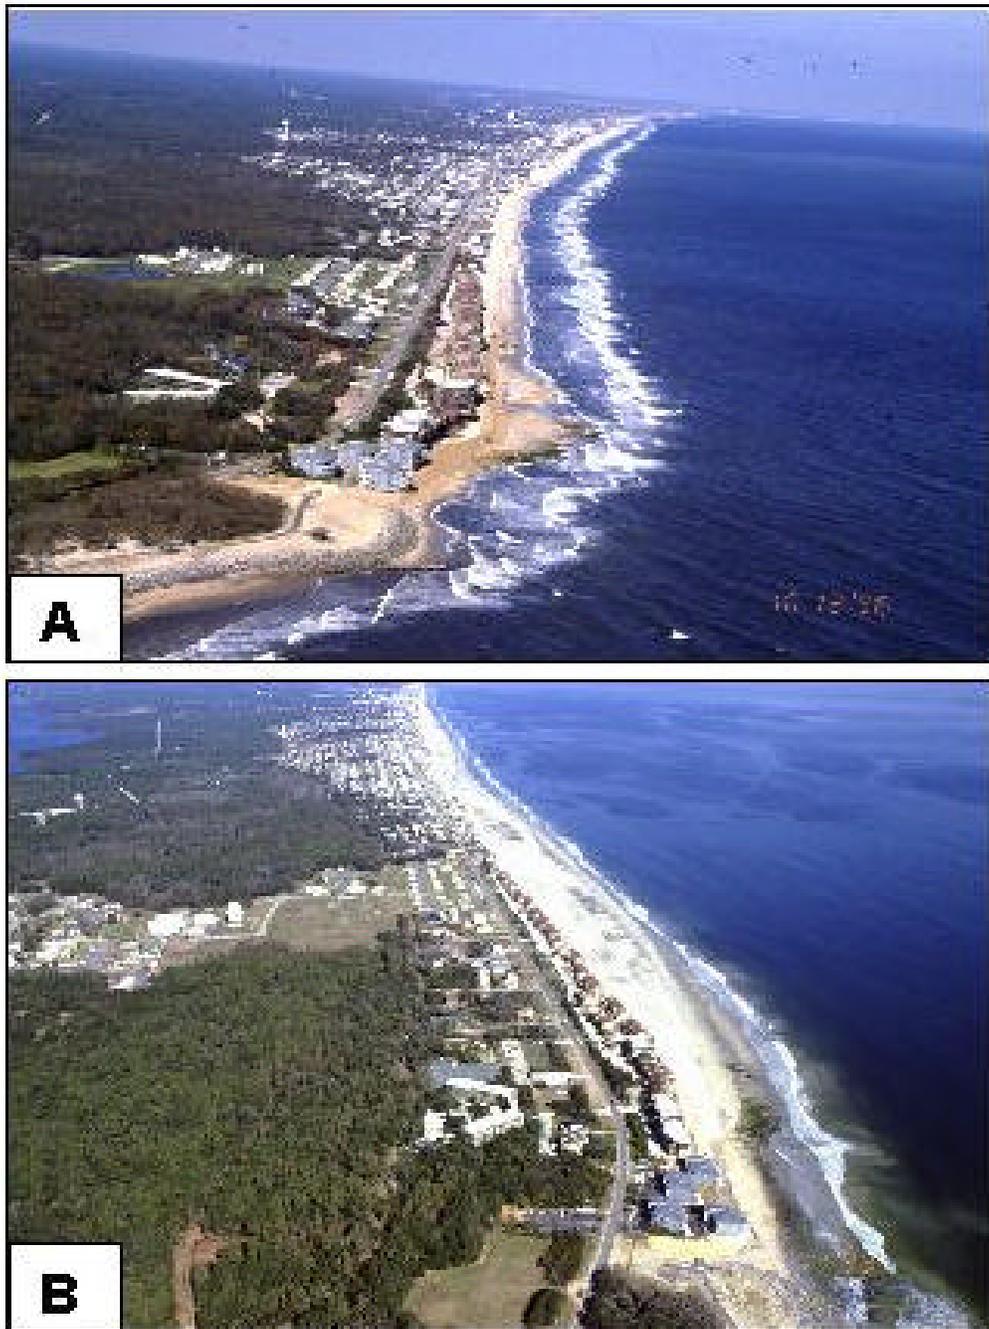
Plate E-12:

Plate 12. North views of the Carolina Beach/Kure Beach subaerial headland shoreline segment. A.) View (10/12/96) from the seawall at Fort fisher shows the narrow beach and the coquina outcropping along the southern section of the area. The erosion resistant calcarenite forms a small protuberance in the shoreline. B.) North view (1/11/98) from the terminus of the seawall at Fort Fisher showing the replenishment project at Kure Beach. Coquina outcrop[is visible at the bottom of the photograph. Beachfill was derived from ancestral channels of the Caer Fear river several miles offshore.

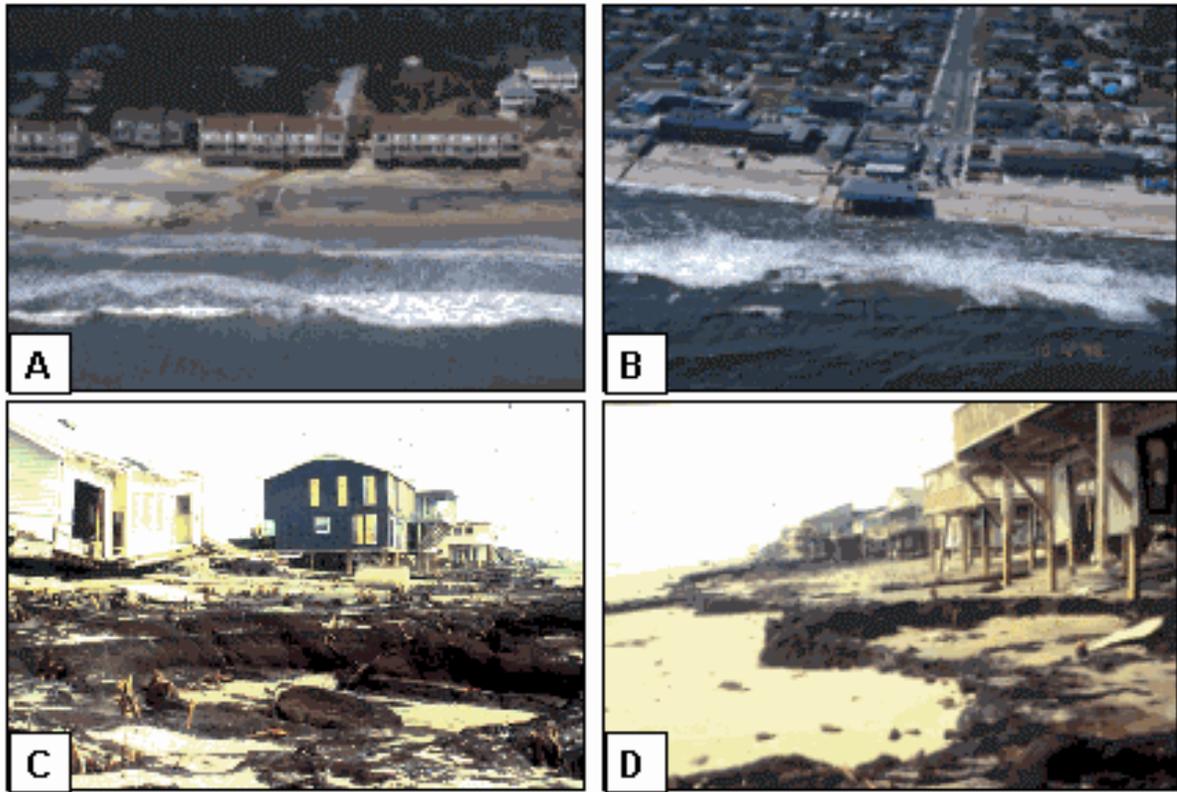
Plate E-13:

Plate 13. View of damage and beach erosion following Hurricane Fran (9/6/96). Photographs C and D by Robert Young. Southern portion of Kure Beach (9/6/96). Perched beach was eroded exposing underlying humate sandstone and Pleistocene stump forest. B.) Groin field and pier at Kure Beach (10/12/96). Minor damage occurred along this stretch of shoreline and for the most part damage was confined to the oceanfront row. Overwash extended across the road. C.) South view of the outcrop of the humate sand and stumps. Modern beach was very thin along much of this area. D.) Northern extension of sandstone unit contains less stumps. Remnants of this unit can also be found in the nearshore area.

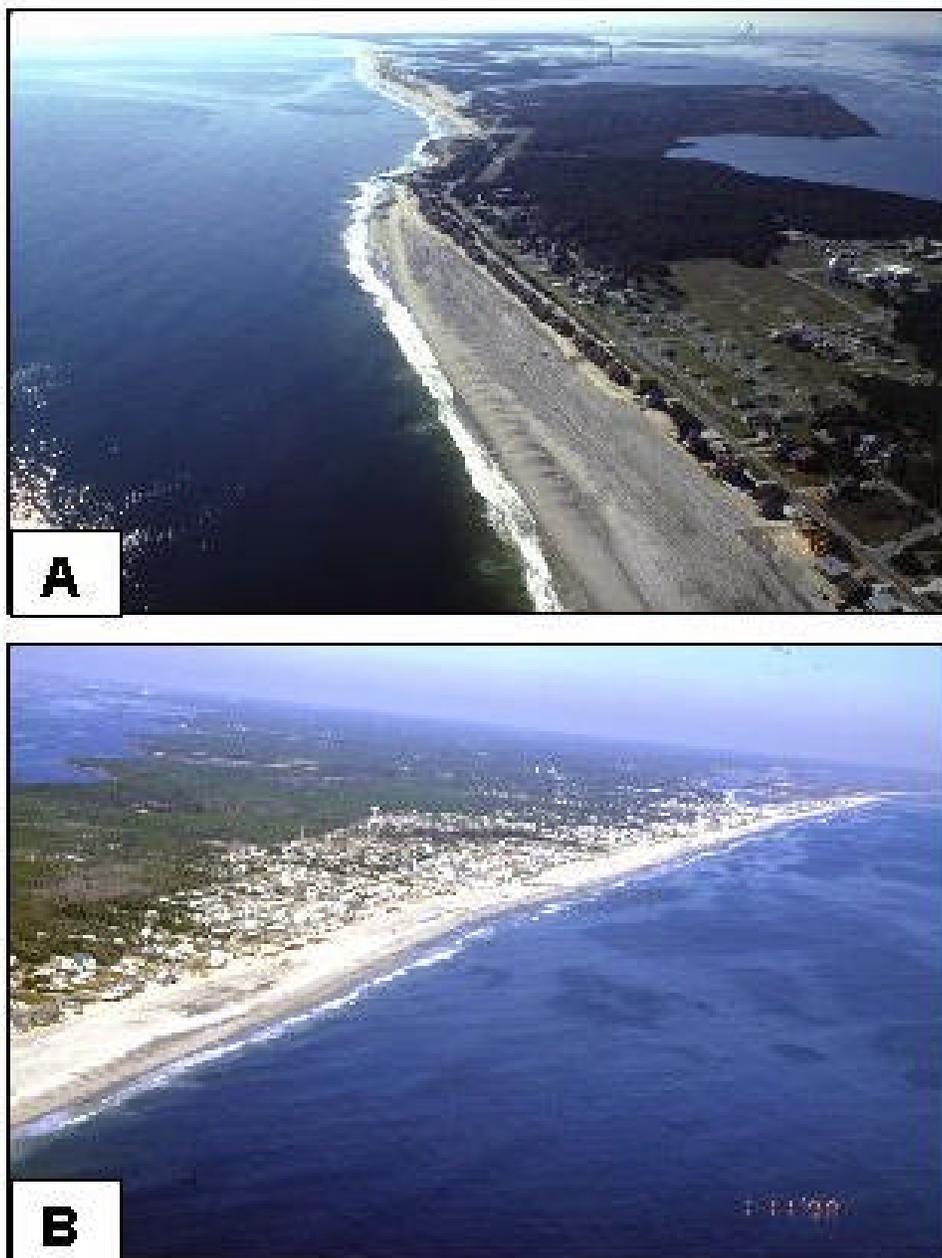
Plate E-14:

Plate 14. Views of replenishment project at Kure Beach. A.) South view (1/11/98) of project and terminus just north of Forth Fisher. Shoreline offset toward top of photo is related to the contrasting nature of the underlying materials. Sheephead Rock is located offshore in upper left corner. B.) Landward view (1/11/98) of northern portion of the replenishment project at Kure Beach and the remainder of the headland segment. Carolina Beach Inlet is seen in the upper right of the view.
