*NATIONAL WETLAND MITIGATION  
BANKING STUDY  
The Early Mitigation Banks:  
A Follow-up Review*

**WORKING PAPER**

**Institute for Water Resources  
Water Resources Support Center  
U.S. Army Corps of Engineers  
Alexandria, Virginia 22315**

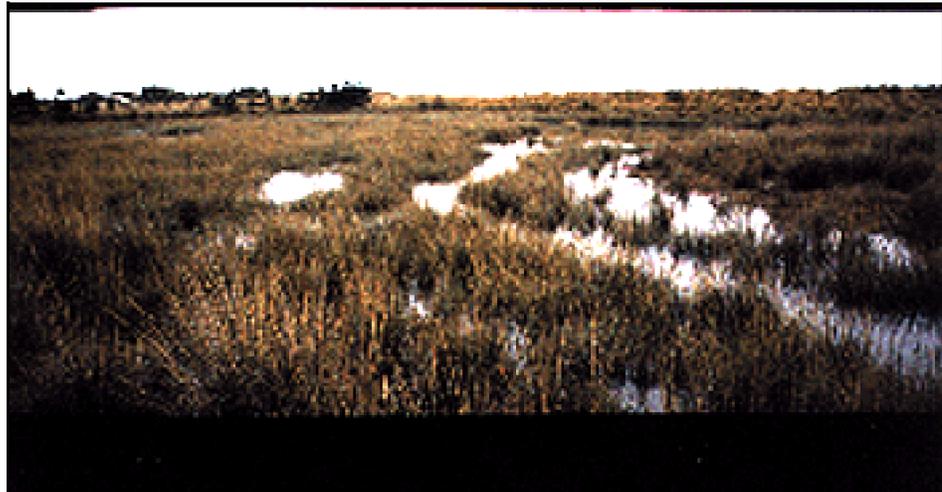
**Figure 2.** Tidal wetlands, Bracut Marsh Mitigation Bank, September 1996

**Corrective Action:** In 1988, a biological survey was completed which made recommendations for corrective actions. During 1988, Phase I of the restoration work was completed—planting to buffer the marsh from incompatible adjacent land use. A vegetation survey was conducted in 1991 which showed that the site was performing better than the pre-restoration (pre-bank) condition. By 1991, two rare plant species had colonized the marsh, although plant species diversity was low. In 1992-1993, the Community Action Agency, which took charge of the enhancement of the marsh, had made the decision to enhance the biological diversity by improving the compacted soil and further by breaching the levee. The Phase II levee breach was expected to negatively impact the rare plant species, therefore, a seed bank was collected to be used as stock following the levee breach. The elevation at portions of the site was lowered and tidal channels were excavated. In September 1994, a vegetation survey showed that the rare plants had not recolonized and there had not been significant additional recruitment of other native tidal marsh species, even though the area of tidal pools had increased on the site. Currently, the project site consists of tidal pools/marsh, freshwater/brackish wetlands, a wetland upland transition zone, mudflats, and uplands (Figure 2).

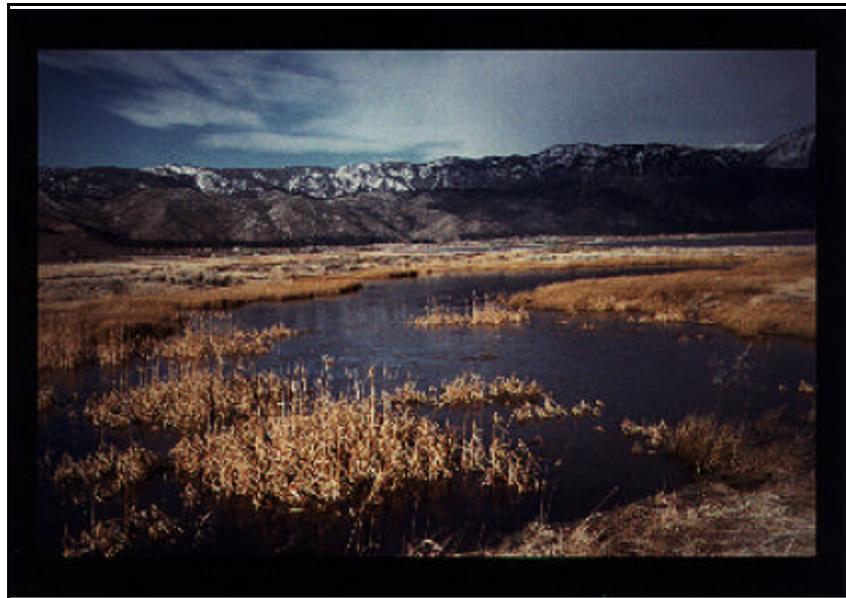
**Figure 3.** Shallow water and emergent wetland, Washoe Wetland Mitigation Bank, November 1996. Looking at west from easternmost edge of bank (photograph courtesy of Stephanie Wilson, EPA).
